**Sacramento Home Inspections +**  
3001 19th Ave Unit C  
Sacramento CA 95820  
916-501-0820  
mthick2008@gmail.com

## **Confidential Inspection Report**

5678 Infinity Rd  
Sacramento, CA 95820

**August 20, 2019**

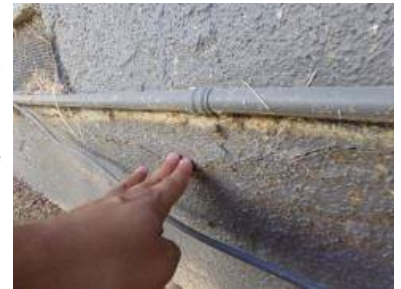
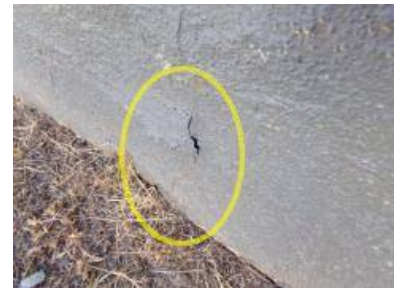
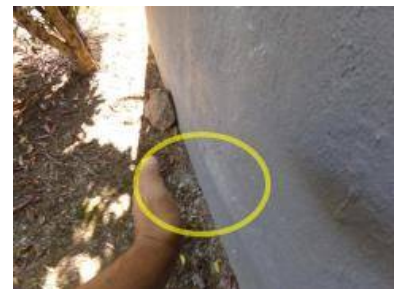
There is cracked and unbonded stucco at lower portions of the home. This appears to be due to the foundation rotating (See foundation comments). These surfaces cannot be effectively patched. We recommend that all unbonded material be removed and replaced.

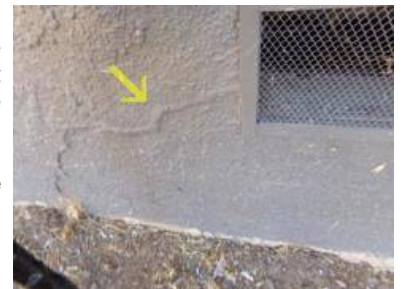
Several patched over cracks were noted which indicates movement. These surfaces can be patched but if movement in the structure is not addressed the cracks may return and/or become more prominent. If client is concerned with the condition noted, we recommend a full evaluation and/or corrections by a specialist in the appropriate trade.

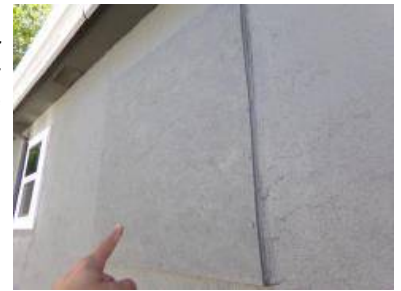
Section of the siding (left of home) was patched is OSB. This material is not adequate for exterior siding and is prone to deterioration and will blister over time . We recommend that this material be removed and the area be properly sealed with stucco to match adjacent surfaces.

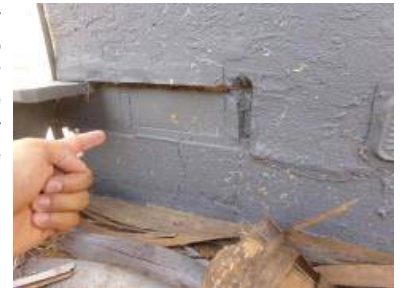
Right side of the home by the bedroom exterior door has exposed floor joists and rim joists. The stucco was removed from this location but not properly repaired with moisture barrier and stucco. We recommend that client contact a licensed contractor for further evaluation and determination of the necessary corrective measures.

Deterioration noted on floor and rim joists in this area as well. We suggest further evaluation by a Licensed Branch III Structural Pest Control Operator for identification and any remediation deemed necessary by the pest control company.

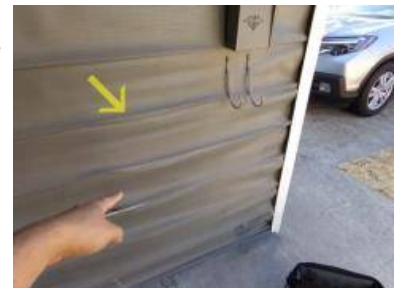
Vinyl siding at the front of the home was damaged, melted and loose in multiple locations. We recommend that all damaged and loose materials be repaired or replaced by a licensed contractor.

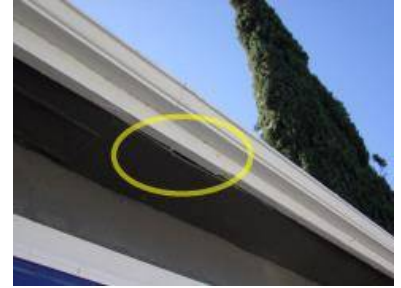
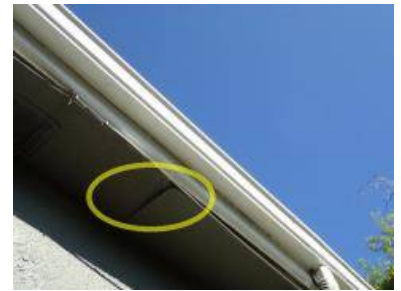
Soffits are loose and/or have gaps in various locations which can allow moisture and/or pest intrusion. We recommend that a license contractor review and correct the conditions noted.

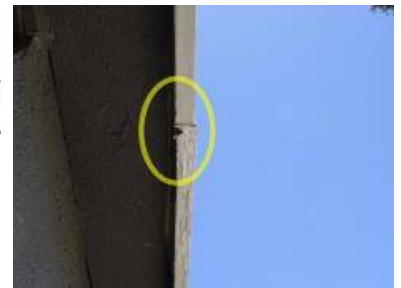
Wood fascia joints on the right side of the garage was deteriorated. We recommend inspection/evaluation of wood trim material by a Licensed, Branch III, Structural Pest Control Operator to determine whether any remediation is deemed necessary at this time.

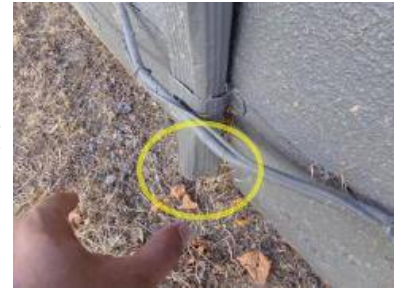
Downspout turnouts are missing.

[NOTE] - Recommend installing positively angled downspout extensions, or tying downspouts into an underground drainage system (if feasible), so as to prevent water from ponding/pooling at or near building foundation.

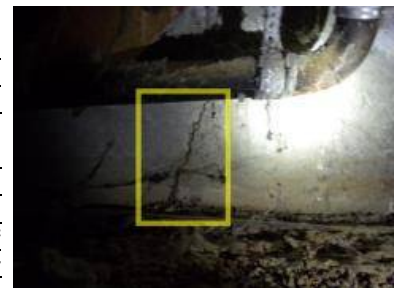
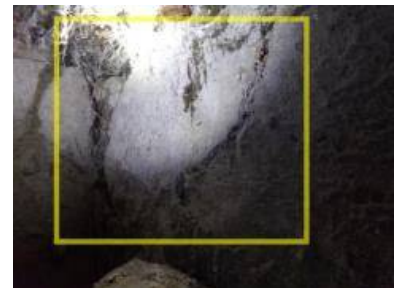
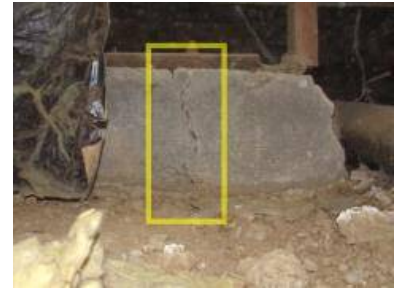
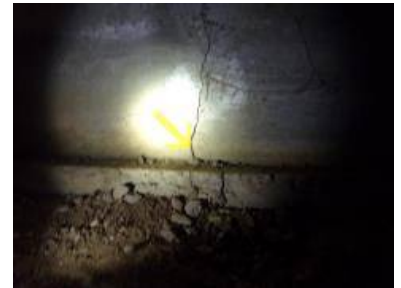
110 Foundation:

- The foundation has significant cracking, settling and/or rotation in various locations. Cause of the conditions noted can be caused by various factors (moisture compacting soils, etc).

While the foundation may function we suggest further review/inspection by a qualified foundation specialist or structural engineer. Qualified engineers can be retained for evaluation of internal stability of the foundation and soils beneath them, and for analysis and prediction of future performance.

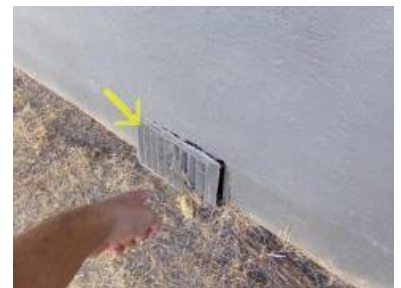
- Improper hatch cover was noted. We recommend that the hatch cover be replaced.

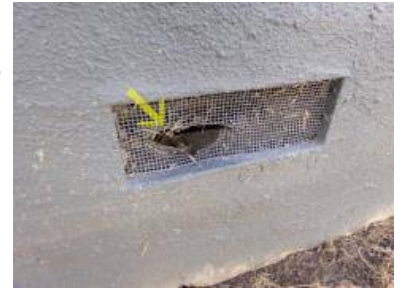
Ventilation appears to be adequate. Screens noted.  
- Exterior ventilation screens were noted to be torn, damaged and/or missing. We recommend they be replaced to keep animals out of the crawl space.

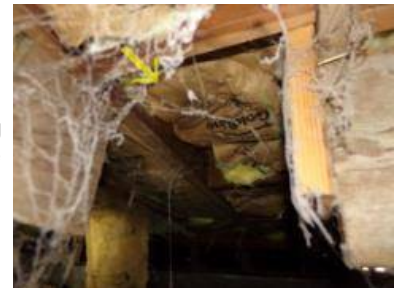
The floor support framing under the rear left side of the home (laundry area) was provided with fiberglass insulation. This helps to save energy and seasonal heating costs. It should be noted that a full and thorough visual inspection of the floor framing support system could not be performed due to the installation of insulation.

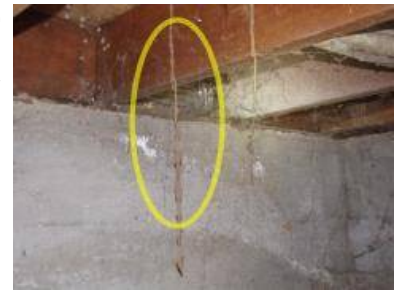
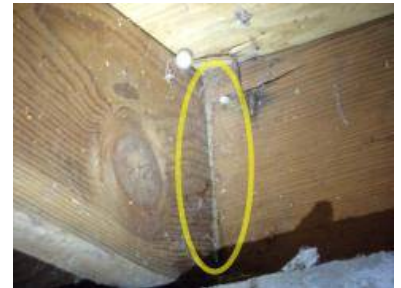
Evidence of WDO (Wood Destroying Organism) activity noted in sub area. We recommend inspection/evaluation of wood integrity in sub area by a licensed, Branch III, structural pest control operator in order to determine whether any (further) remediation is deemed necessary at this time.

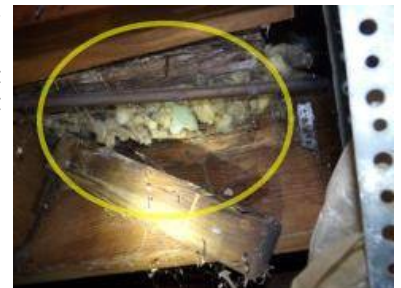
Deteriorated framing and sub-floor was noted under the master bathroom area. Although the areas were dry during time of inspection we suggest inspection/evaluation by a Licensed Structural Pest Control Operator to determine if any remediation is deemed necessary by the pest control company.

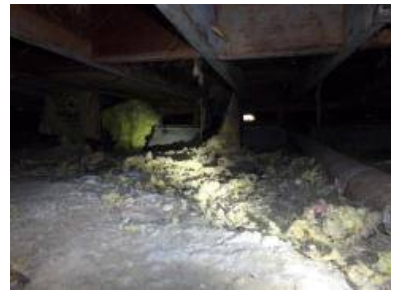
Abandoned building materials and insulation was noted. Such items are a hindrance. Sub area should be made totally accessible for future contractors needing to do inspections and/or repairs in sub area. Recommend removing any/all such abandoned items.

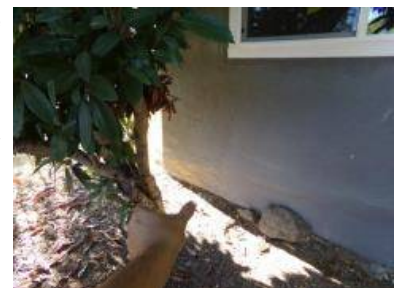
Trees/limbs in close proximity to a building are always a concern and the condition of such trees and their limbs should be professionally evaluated. Recommend further evaluation of any nearby trees, and a trimming or removal bid as needed, by a professional arborist at this time.

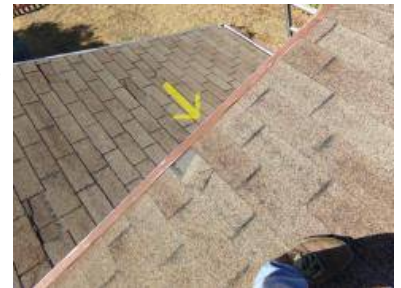
Roof drip edge flashing is improperly installed on top of the roof shingles. Flashing should be installed on top of the wood sheathing and then have the moisture barrier and shingles on top of it.

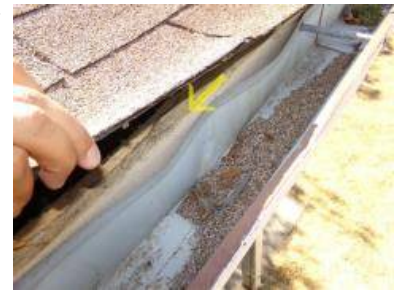
No gutter flashing was installed to prevent water from leaking onto the roof sheathing.

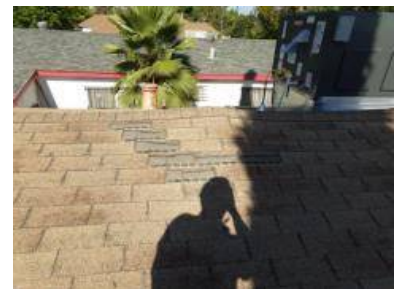
Split and/or damaged and/or missing shingles noted. We recommend further review/evaluation and/or replacement bid by a licensed roofer.

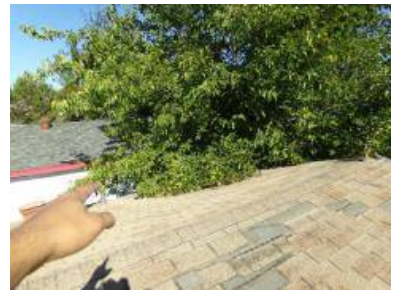
Roof sheathing was deteriorated on the front porch/entry area. We recommend that this material be replaced.

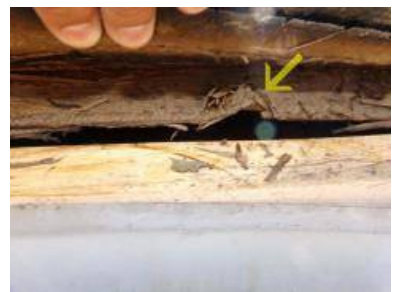
Section of the roof sheathing (front right, near ridge) was flexing when stepped on. We recommend further review/evaluation and/or replacement bid by a licensed roofer.

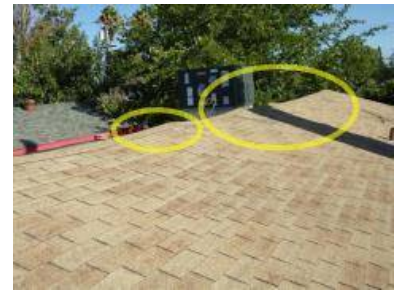
The roof ridge is sagging, it is recommended that further evaluation be made by a licensed general contractor/framing carpenter or if necessary, a structural engineer.

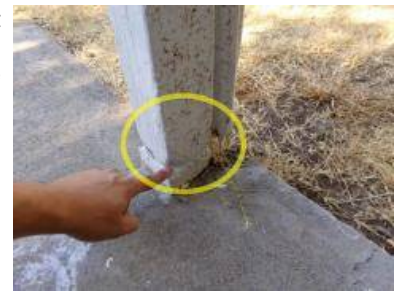
No metal post bases installed. Although not required during time of construction, we recommend installing them to premature deterioration to the bottom of the wood posts.

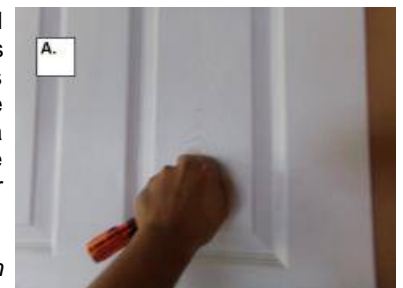
A.) Door is a hollow interior door not a fire rated door (solid door with 20 minute burn rate) as required. B.) Lacks required self closer. C.) Lacks required smoke seal (weather stripping). D.) The landing was too small. The landing should be a minimum of at least three feet square. We recommend correcting the condition(s) noted for safety reasons. E.) Lacks threshold.

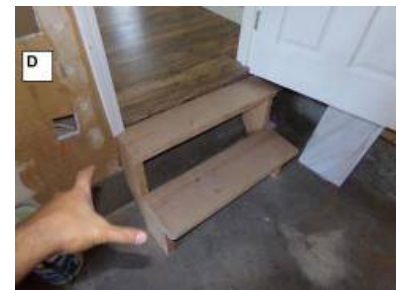
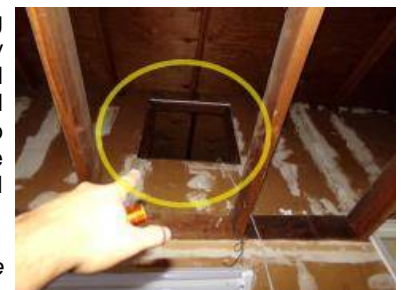
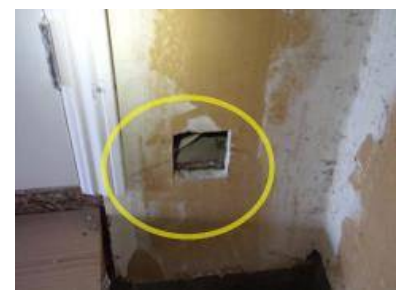
608 Fire wall.

Fire barrier between this attached garage and living quarters is compromised in multiple locations. Any exposed fire wall framing members, damaged areas, openings or use of improper materials should be (re)sealed with approved materials so as to restore the fire-resistant barrier as required. We recommend further review/correction by qualified contractor.

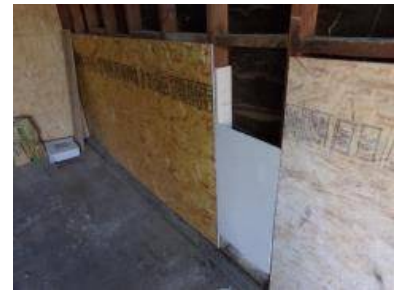
609 Walls:

Walls/framing were covered with OSB sheets. Unable to fully view all exterior wall framing.

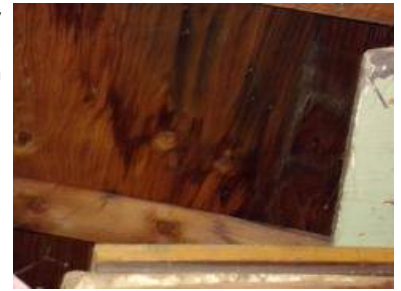
610 Ceiling/rafters:

Water stains noted, advise consulting with property owner to provide information regarding the cause and what corrective actions were taken in mediating this potential defect.

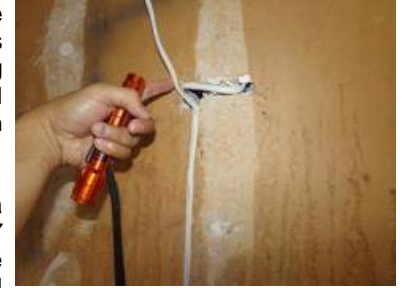
A.) Exposed high voltage wiring noted (below the standard 7' from ground). This condition is considered to be a safety concern since the wiring is located where it could be subject to physical damage. We recommend further review/correction by a licensed electrician, for safety reasons.

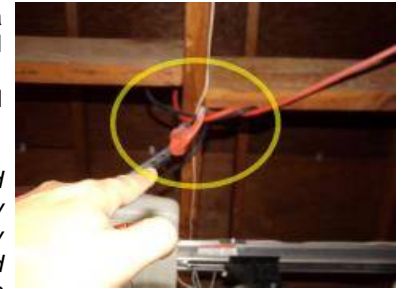
This garage door opener(s) is equipped with a safety reverse and/or stop device which operated when tested at the time of our inspection.  
- Run with extension cord - this is not an approved installation.

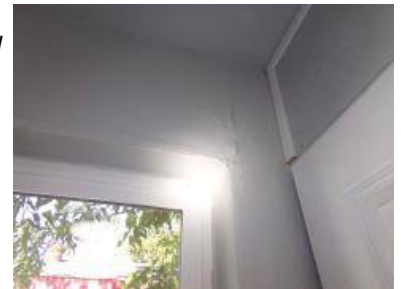
Stress/shrinkage/settlement cracks noted

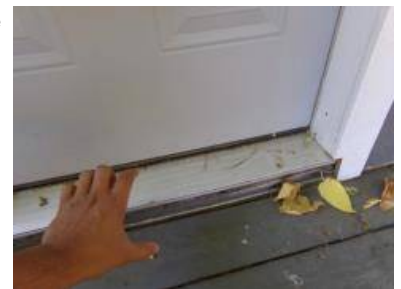
Exterior door threshold flexes when stepped on. We recommend correcting this condition.

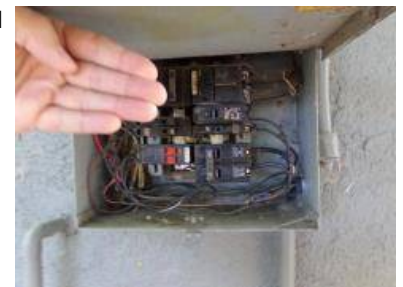
Missing protective panel cover(s). We recommend correcting the condition(s) noted.

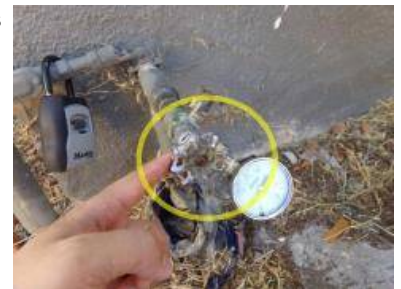
Front hose bib leaks when operated. Correction is recommended.

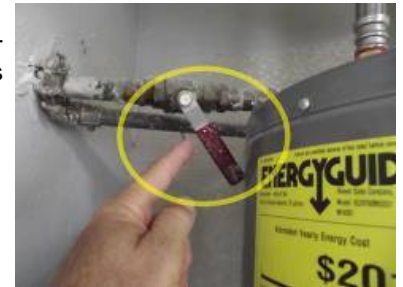
- Shut-off valve makes contact with the water heater and does not fully open. We recommend that this condition be corrected by a licensed plumber.

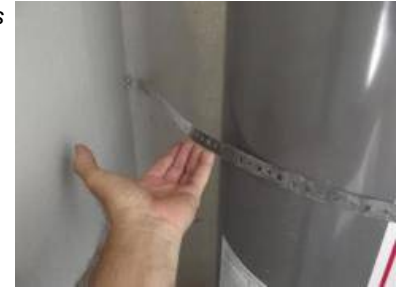
Lacks required earthquake safety straps. \*Plumbers tape installed is not considered a seismic strap.

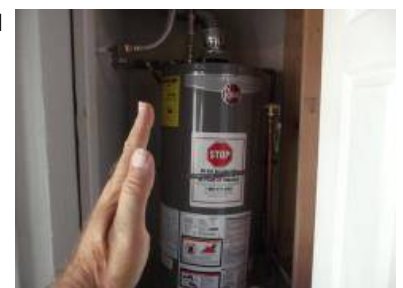
Unit was not installed vertically. We recommend correcting the condition noted.

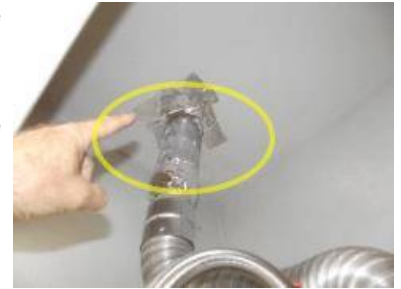
There was no collar/bucket to separate the flue vent pipe from the sheetrock ceiling. The collar/bucket is needed to provide adequate clearance to minimize heat transfer to combustible materials. We recommend correcting the condition(s) noted for safety reasons.

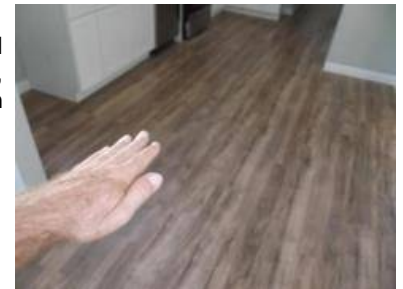
- The floor is sloped. Individual perception and sensitivity to floor sloping varies greatly. However, the slope in this case is significant. See foundation section of this report regarding this issue.

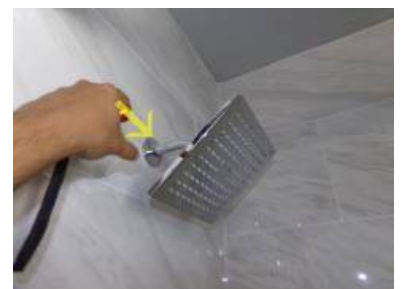
Loose pipe noted.

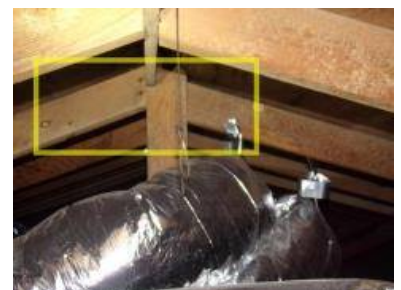
Broken rafter was noted at the rear left side of the attic. We recommend that client contact a licensed contractor for further evaluation and determination of the necessary corrective measures.

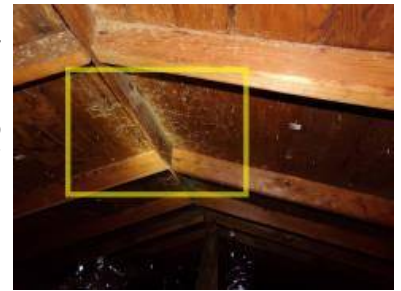
Spores noted on surfaces of the roof sheathing and framing members. Appears to be due to poor ventilation and the kitchen vent and master bath fan blowing air into the attic space. We recommend these surfaces be cleaned and chemically treated to remove the growth. We also recommend further investigation by a professional if client is concerned.
