Sacramento Home Inspections +

Confidential Inspection Report

1234 Nowhere Dr,
Sacramento, CA 95820

September 2, 2019

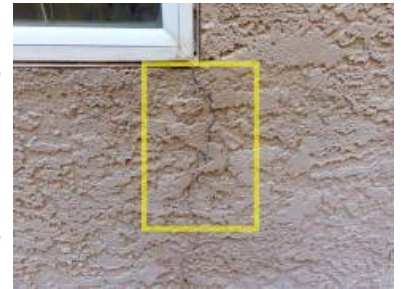
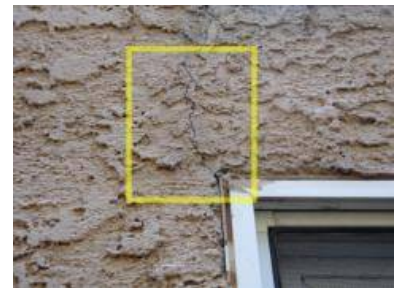
101 Siding:

The siding material is an exterior finish insulated stucco. Several cracks noted around the windows and doors. Cracks noted in stucco are common due to the shrinkage in the wood framing. This occurs during the construction when lumber is damp. When the wood finally dries it shrinks and causes the exterior siding material to move which causes cracks. The cracks noted can be caulked and painted in the course of routine maintenance. - We recommend a full evaluation and/or corrections by a specialist in the appropriate trade if concerned.

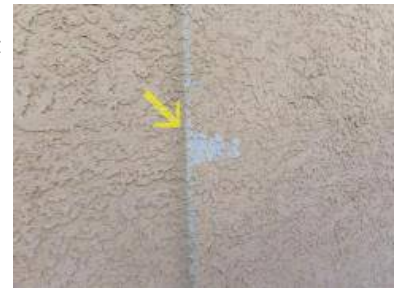
Stucco on the right side of the garage was discolored. Suggest painting to match adjacent surface color.

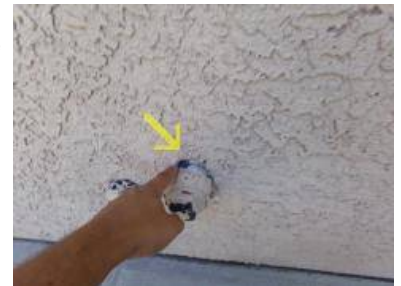
Some chipping stucco noted around the rear drain cleanout. Suggest sealing to prevent moisture intrusion.

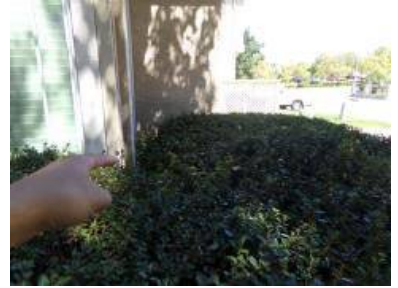
Suggest trimming all trees and vegetation away from home. Vegetation in contact with or encroaching with building materials may trap moisture causing damage/deterioration, harbor insects or rodents and allow the growth of mold/mildew.

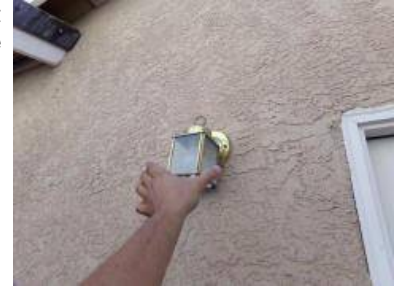
104 Electric Fixtures:

The exterior light(s) are loose and not sealed/caulked at the wall to prevent moisture intrusion.

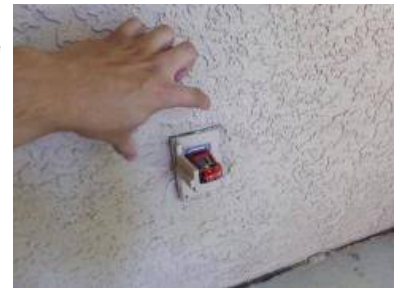
Outlet by the front entry was functional but was loose. For maximum safety we recommend that the loose outlet be tightened.

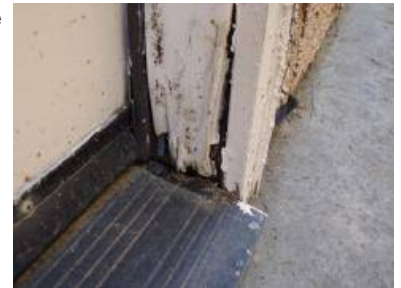
Garage access door jamb was deteriorated. We recommend that this condition be repaired.

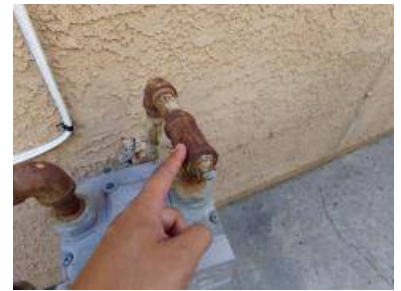
Rust noted on gas pipe, suggest repainting rusted surfaces.

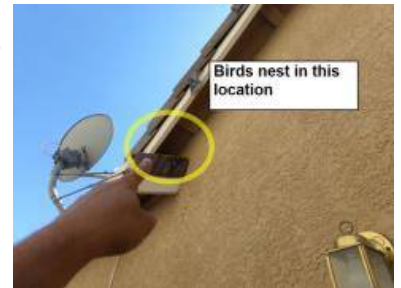
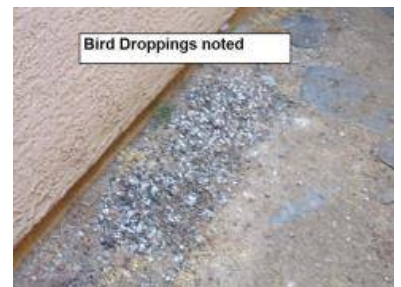
Nesting birds noted. If concerned, we recommend that client contract a bird remediation company to installed netting or bird spikes.

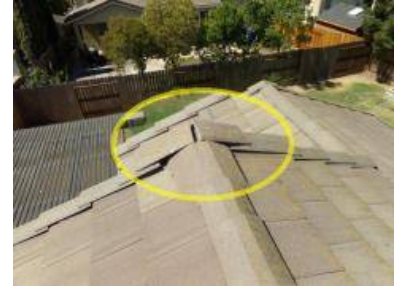
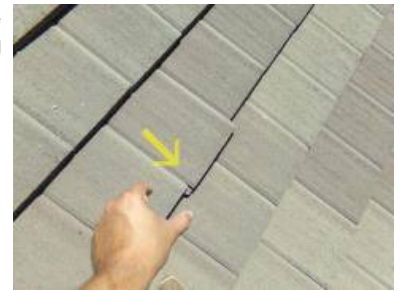
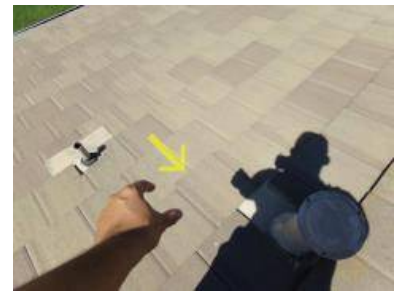
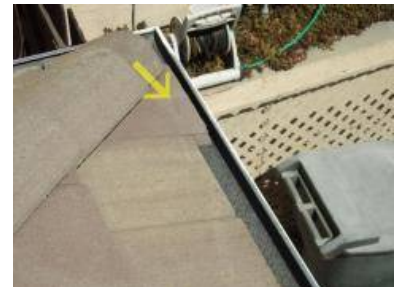
Several roof tiles have slipped down. We recommend client contact a licensed roofing contractor to locate, reposition and secure all loose tiles.

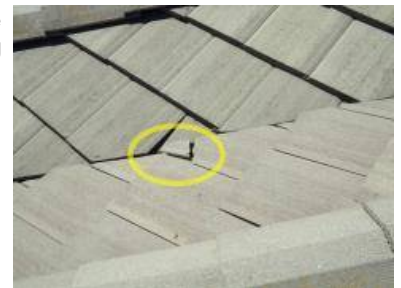
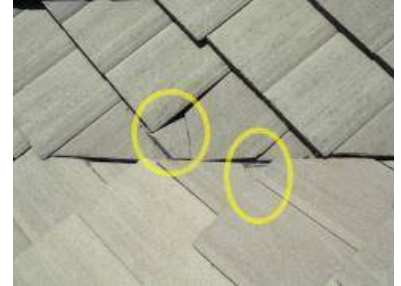
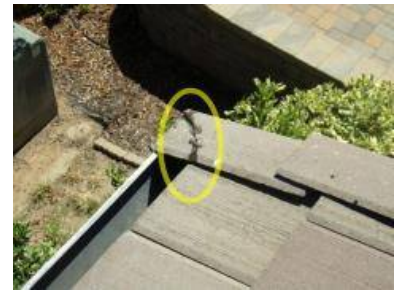
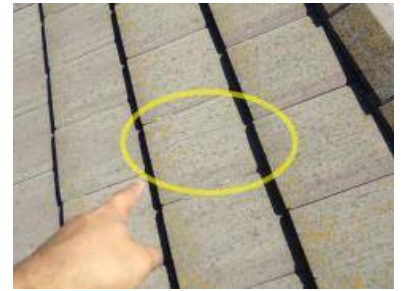
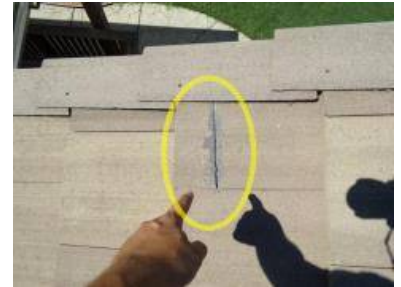
Several roof tiles are broken and/or cracked. We recommend client contact a licensed roofing contractor to locate, repair and/or replace all damaged tiles.

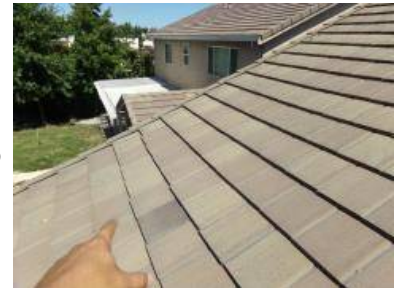
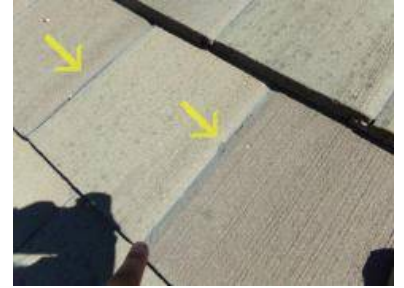
Several of the tiles on the rear right side of the roof have sealant between each joint. Sealant between each joint is unnecessary and is not standard when installed. This has not appeared to have caused any adverse conditions; however, if client is concerned we recommend contacting the seller to learn more information.

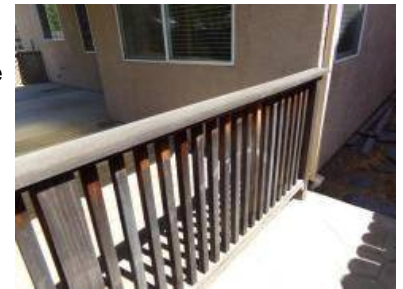
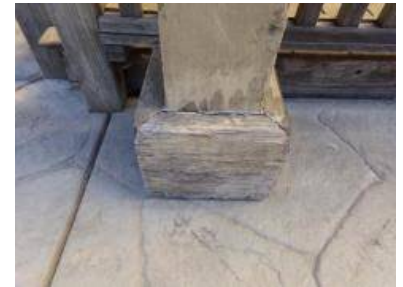
[NOTE] - Rails and spindles are weathered, we recommend that the patio cover be re-stained.

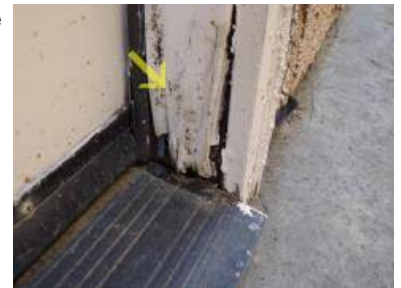
Garage access door jamb was deteriorated. We recommend that this condition be repaired.

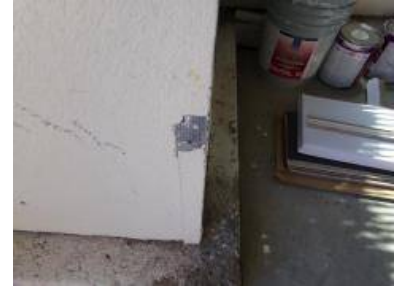
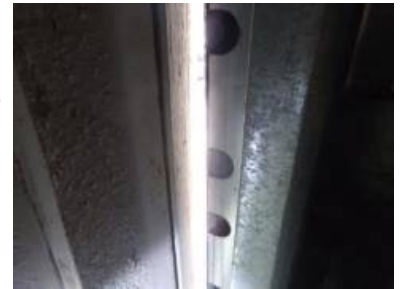
- Daylight and gaps were noted around the door. This condition can allow pests to enter into the garage. May need additional weather seals to correct the condition.

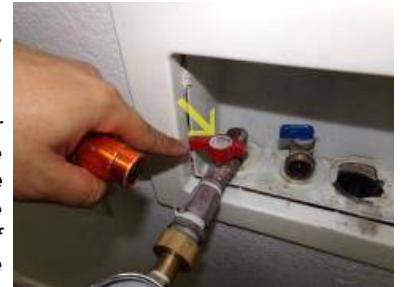
716 Washer Service Hot handle was difficult to operate. We recommend that the valve be reviewed, repaired or replaced by a licensed plumber

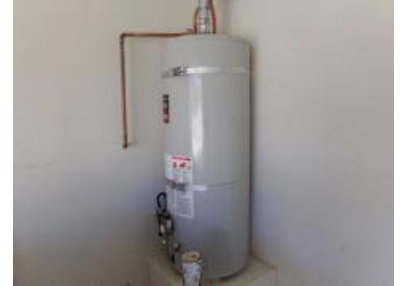
805a Water Heater #1: 50 gallon Gas unit.

[NOTE] - Unit is 19 years old and is beyond the manufacturers expected service life. It was however working properly during time of the inspection, but we suggest having a budget for replacement in the future.

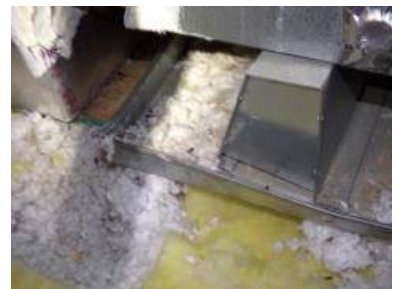
Debris in safety drain pan should be removed to prevent clogging of secondary drain.

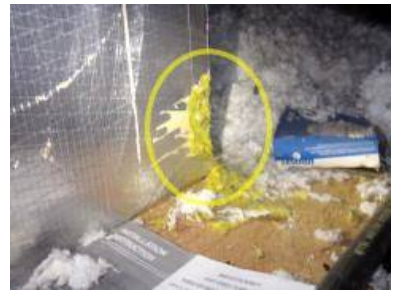
Some of the duct board was chewed by rodents. We recommend that the duct board be repaired by a licensed HVAC tech.

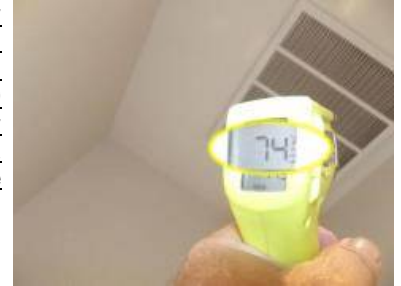
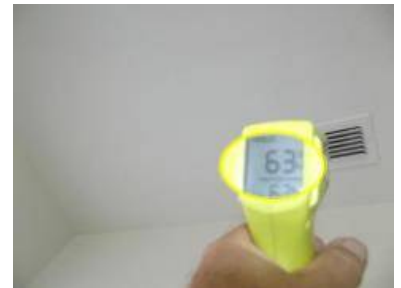
Supply air temperature measured approximately 63°F. Return air temperature measured approximately 74°F. Temperature drop/differential observed was less than the recommended 15 - 20 degrees. (taken between interior return and supply air). The unit may have not been serviced, a licensed HVAC specialist should be called to make further evaluation .

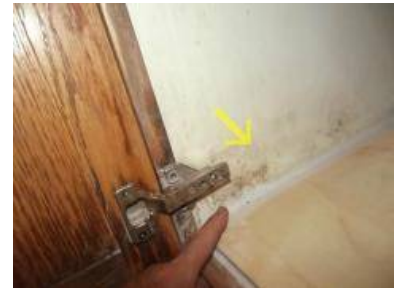
901 Floor: S; LVT (Luxury Vinyl)
 902 Walls: S
 903 Ceiling: S
 904 Doors: S
 905 Windows: S
 906 Screens: S
 907 Cabinets: Water damage noted on sides of sink cabinet from a previous leak.

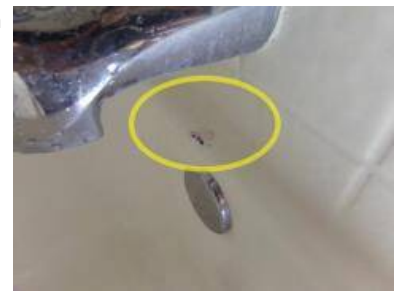
Small surface chip noted. Suggest sealing with epoxy if concerned.

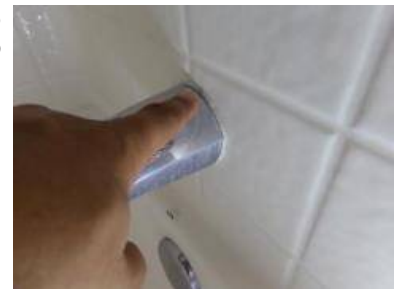
- 1012 Tub Faucet: A.) The faucet(s)/spout were not sealed/caulked to the wall/deck. This condition is conducive to moisture intrusion into concealed spaces. Correction of the condition is advised.
B.) Tub faucet was loose.

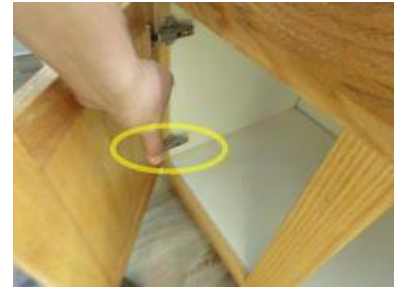
Loose cabinet hinge noted.

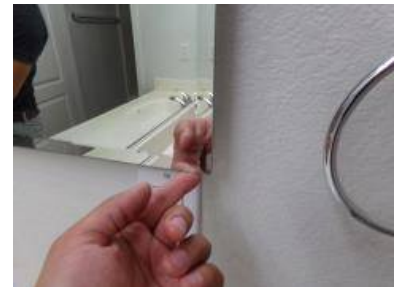
Chipped corner noted on medicine cabinet.

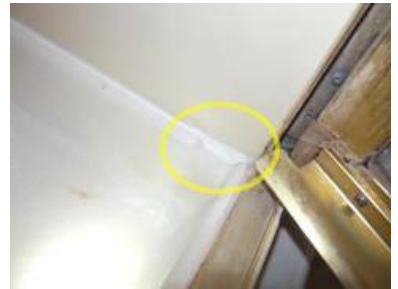
Shower pan weep holes were sealed. These weep holes should not be caulked or grouted over. If water ever gets trapped behind the tiles the weep holes allow water to drain out. We recommend correcting the condition noted.

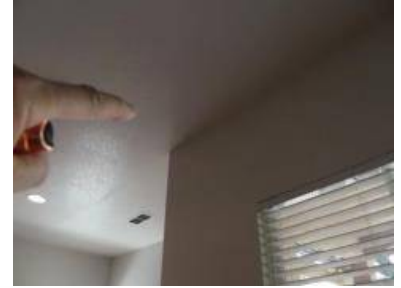
1213 Ceiling: Stress/shrinkage/settlement cracks noted.

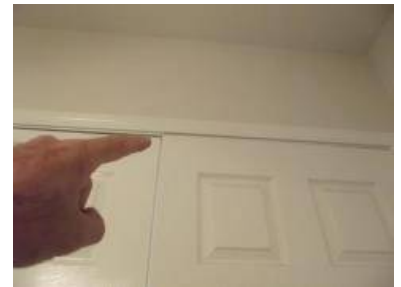
1221 Floor: S; LVT (Luxury Vinyl)
 1222 Walls: S
 1223 Ceiling: S
 1224 Doors: One of the doors rubs against the top door jamb. We recommend correcting the condition noted.

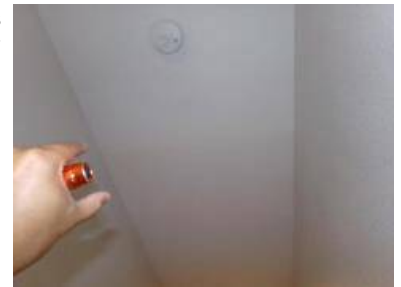
Evidence of patching noted. The cause of this condition is unknown. Recommend that the seller be consulted for explanation.

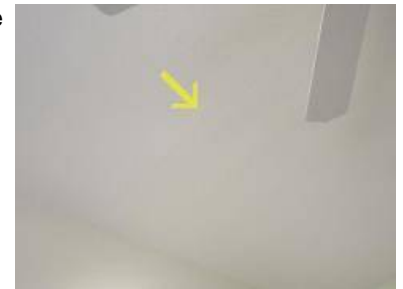
Stress/shrinkage/settlement crack noted by the ceiling fan.

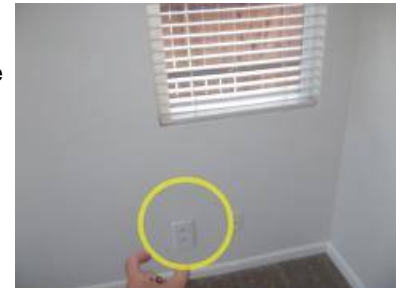
- One outlet was loose. For maximum safety we recommend that the loose outlet be re-secured.

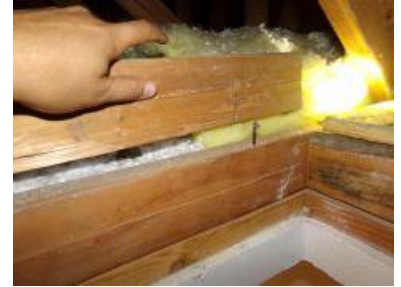
Located in master bedroom closet.
- One of the 2x4 hatch framing members was loose.

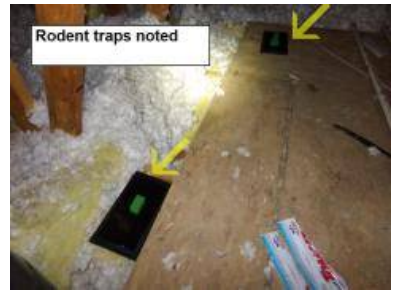
Evidence of past rodent activity noted in attic. Rodents are a potential source of damage and disease. Recommend further review/correction by qualified contractor (Branch II pest inspector) at this time.

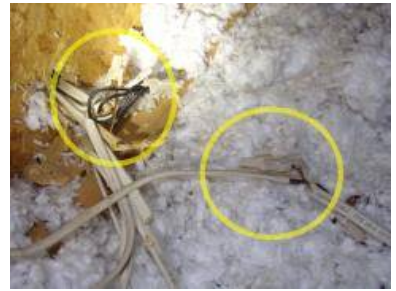
Open electrical wire splices were noted near the laundry dryer vent pipe. This is a safety concern. Whenever an electric wire is cut and reconnected, the "splice" should be encased in a covered junction box to prevent shocks and separation of the splice. We suggest review/correction by a licensed electrician to ensure safety.
