**Sacramento Home Inspections +**  
3001 19th Ave Unit C  
Sacramento CA 95820  
916-501-0820  
mthick2008@gmail.com

## **Confidential Inspection Report**

5678 Infinity Rd  
Sacramento, CA 95820

**August 20, 2019**

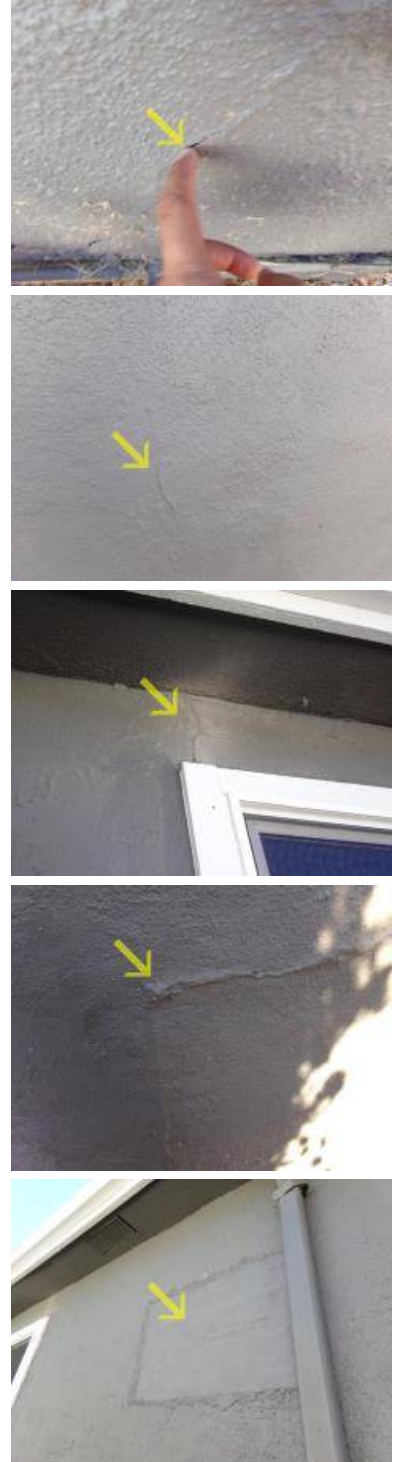
Evidence of patching noted. Patched areas appear to be from removed wall A/C and enclosed garage access door. The patched areas should be kept well maintained and sealed to minimize moisture entry.

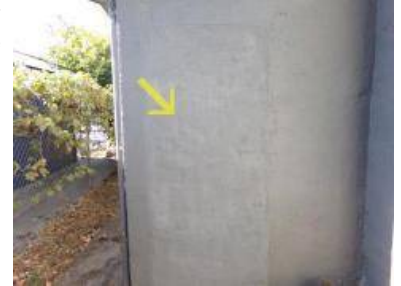
Section of the siding (left of home) was patched is OSB. This material is not adequate for exterior siding and is prone to deterioration and will blister over time . We recommend that this material be removed and the area be properly sealed with stucco to match adjacent surfaces.

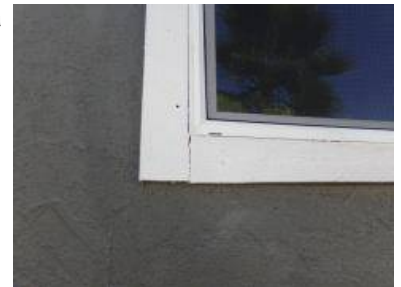
Wood trim around windows have gaps. As a preventative maintenance measure we recommend caulking/sealing all voids at siding joints, common trim, and around windows and doors to avoid the possibility of water intrusion and damage. All wood materials should be kept painted to avoid the possibility of moisture related deterioration.

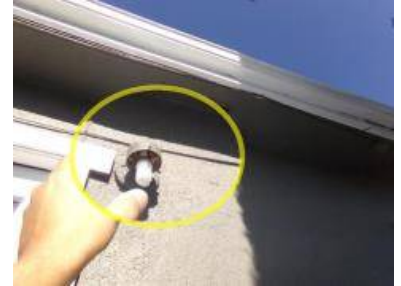
Light fixture by the right side bedroom door lacks globe.

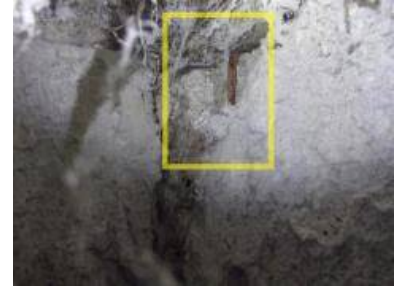
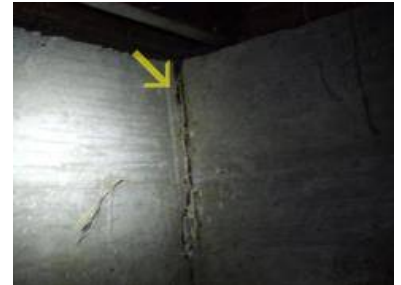
- The foundation has significant cracking, settling and/or rotation in various locations. Cause of the conditions noted can be caused by various factors (moisture compacting soils, etc).

Uneven floors was noted and should be expected in areas; however, the left side of the home has significant sloped floors. We recommend that a qualified contractor be retained to evaluate this condition and determine what corrective repairs may be necessary.

While the foundation may function we suggest further review/inspection by a qualified foundation specialist or structural engineer. Qualified engineers can be retained for evaluation of internal stability of the foundation and soils beneath them, and for analysis and prediction of future performance.

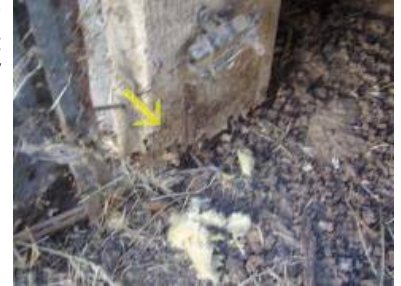
Hatch framing was deteriorated. We suggest further evaluation by a Licensed Branch III Structural Pest Control Operator for identification and any remediation deemed necessary by the pest control company.

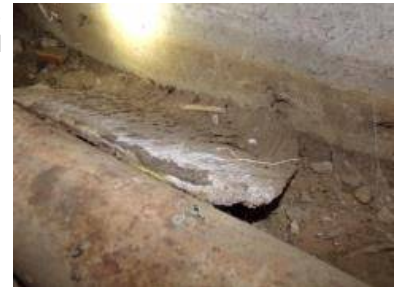
Cellulose/wood and/or plant debris in crawl space area should all be removed so as to avoid (attracting) pest infestation and/or wood destroying organisms.

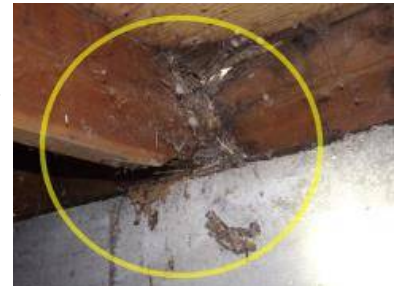
Deterioration noted on floor and rim joists on the right side of the home (by bedroom french doors). We suggest further evaluation by a Licensed Branch III Structural Pest Control Operator for identification and any remediation deemed necessary by the pest control company.

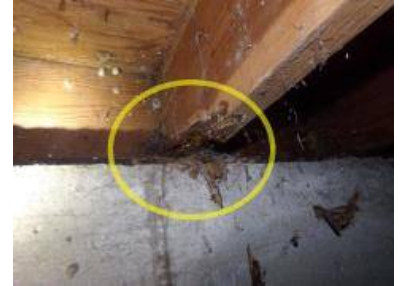
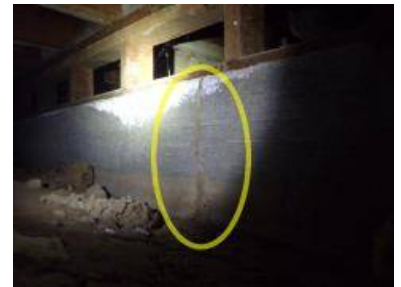
Evidence of WDO (Wood Destroying Organism) activity noted in sub area. We recommend inspection/evaluation of wood integrity in sub area by a licensed, Branch III, structural pest control operator in order to determine whether any (further) remediation is deemed necessary at this time.

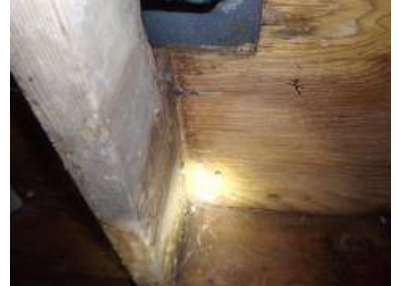
Abandoned building materials and insulation was noted. Such items are a hindrance. Sub area should be made totally accessible for future contractors needing to do inspections and/or repairs in sub area. Recommend removing any/all such abandoned items.

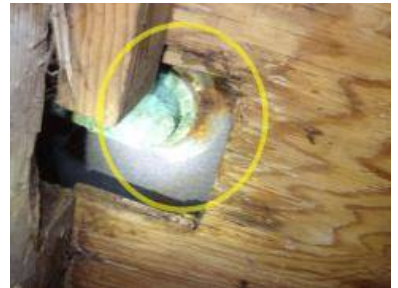
Some rust and corrosion was noted on the master bathroom tub and drain. Although no active leaks were detected, we recommend that client monitor this location for future leaks.

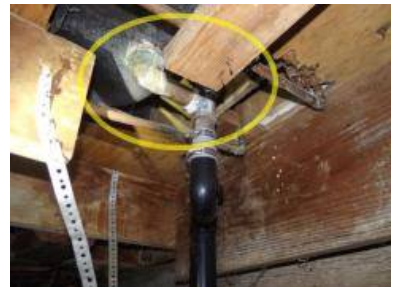
Staining noted at drainage piping under the hallway tub indicates previous leakage. Monitor for leakage in the future.

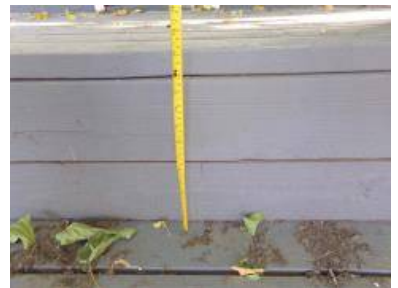
[REAR DECK] - There was improper rise/run on steps/stairs. This condition is a trip hazard. We recommend correcting the condition(s) noted for safety reasons.

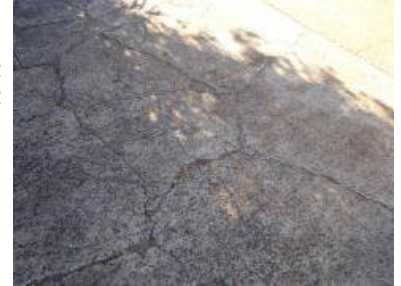
- Cracking noted in driveway. May be due to roots, compacting soils or un-reinforced concrete. If client is concerned about the conditions noted we suggest review/repairs be made by a concrete mason.

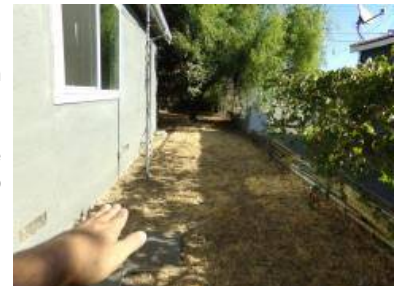
Lot grade within six feet of structure slopes toward foundation. Drainage control system was not noted and may need to be considered/implemented in order to ensure that rain water/run-off is moved away from the foundation of this building if/where needed. Recommend monitoring drainage conditions during periods of heavy rain. We also recommend asking seller if any previous drainage issues have occurred during periods of heavy rain.

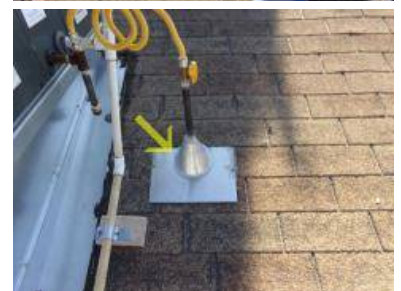
Roof jack flashing installed for the HVAC gas line was not done so according to roofing standards. Client may wish to obtain further review by a licensed roofing contractor.

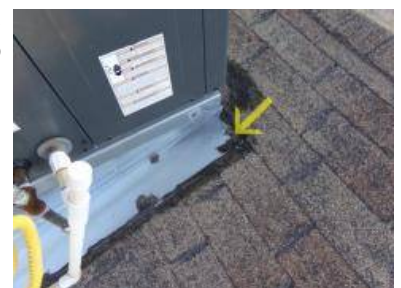
Flashing installed for the HVAC was not done so according to roofing standards. Client may wish to obtain further review by a licensed roofing contractor.

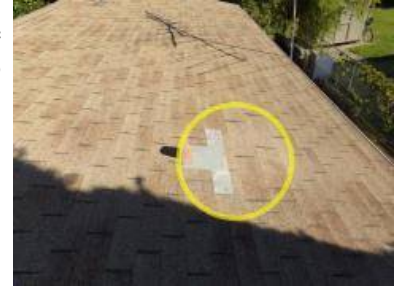
No 'kick-out' flashing installed. The purpose of this type of flashing material is to guide roof run-off water away from chimney chase sides and into gutter(s). We recommend further review of this condition by qualified, licensed roofer.

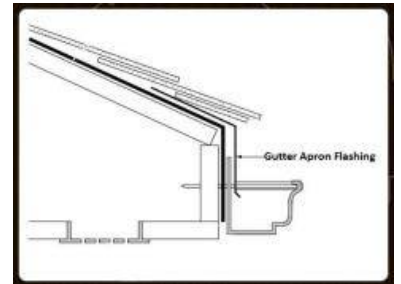
No gutter flashing was installed to prevent water from leaking onto the roof sheathing.

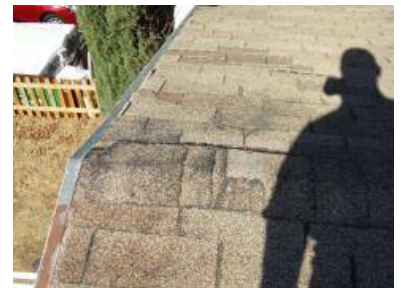
**Roofing materials are deteriorating, damaged and/or missing from a number of areas. Suggest complete review/correction including cost estimate (bids) by a qualified licensed roofing contractor**

Split and/or damaged and/or missing shingles noted. We recommend further review/evaluation and/or replacement bid by a licensed roofer.

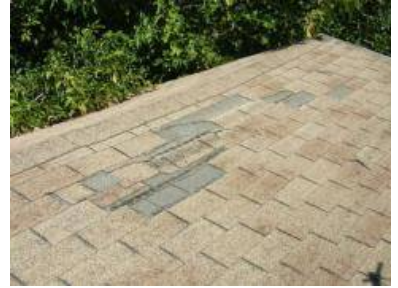
Suggest trimming all trees and vegetation away from roof.

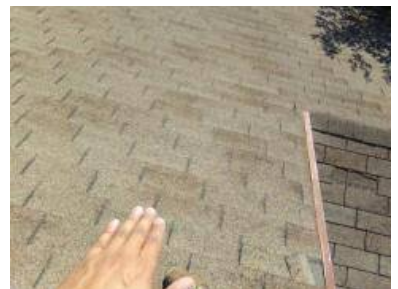
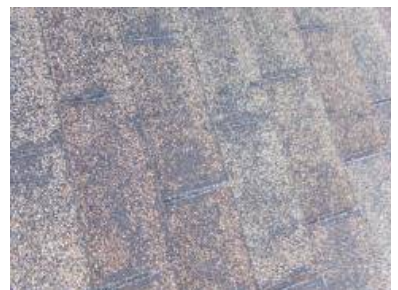
There is extensive surface granulation failure. Many of the shingles have eroded and cracked. These conditions indicate the end of the useful life of this material.

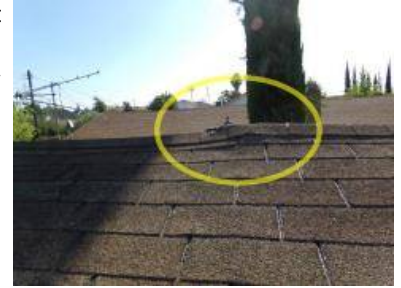
The roof ridge is sagging, it is recommended that further evaluation be made by a licensed general contractor/framing carpenter or if necessary, a structural engineer.

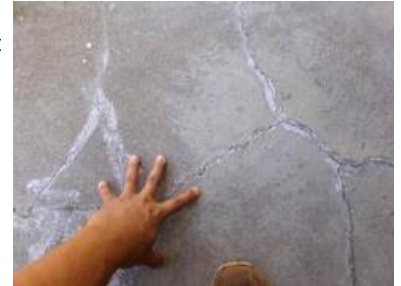
Concrete was cracked and not bonded. If client is concerned about the conditions noted we suggest review/repairs be made by a concrete mason.

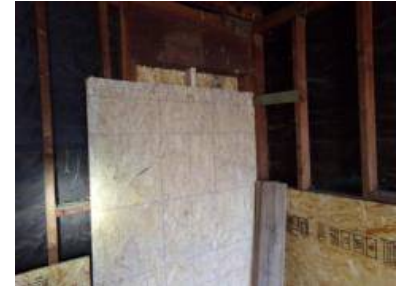
Door was removed and filled in with stucco.

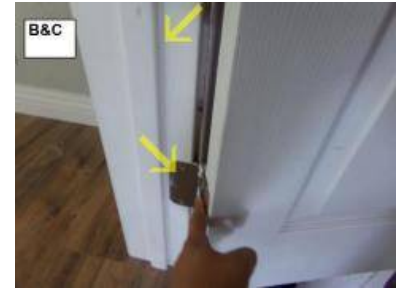
Fire barrier between this attached garage and living quarters is compromised in multiple locations. Any exposed fire wall framing members, damaged areas, openings or use of improper materials should be (re)sealed with approved materials so as to restore the fire-resistant barrier as required. We recommend further review/correction by qualified contractor.

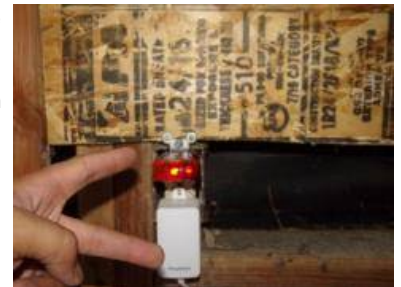
Grounded outlet(s) noted in garage. Building code now requires that all outlets in a garage be GFCI protected. Although not required in this case, upgrading all garage outlets to GFCI protection status is recommended, for safety reasons.

*\*Several outlet covers were missing as well.*

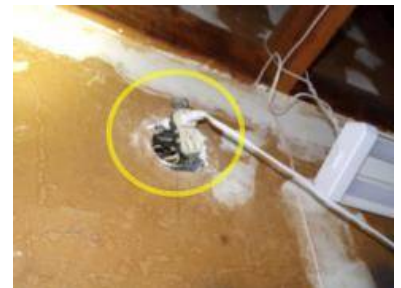
Outlet was loose from the junction box. We recommend correcting this condition. *\*No cover.*

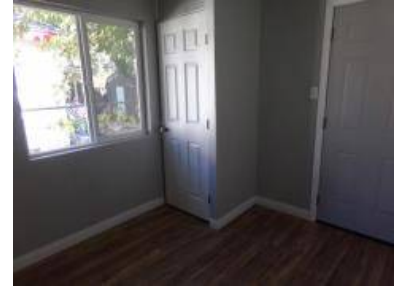
Located at rear left of home.

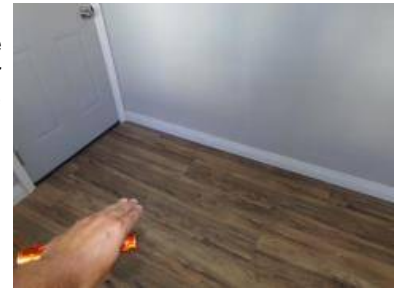
*706 Floor:*

- Flooring has what we consider an excessive bounce. We recommend that a qualified contractor be retained to evaluate this condition and determine what corrective repairs may be necessary.

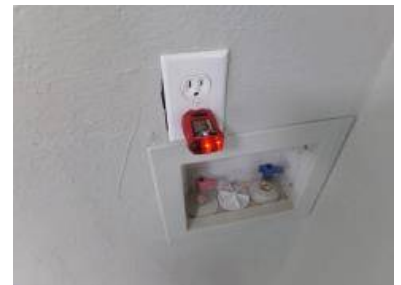
- Outlet was loose. For maximum safety we recommend that loose outlet be re-secured.

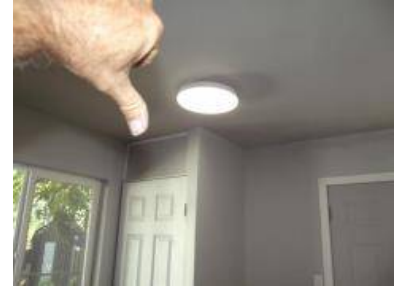
Light works intermittently. Suggest further review be performed by a licensed electrician.

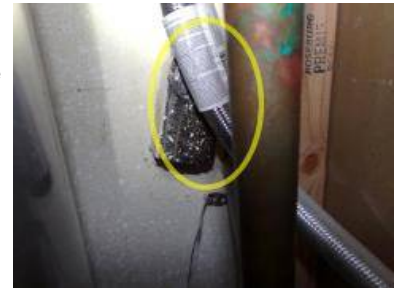
717 Dryer Hookup:

220 v outlet noted.

- Outlet was installed in an inaccessible location (behind the water heater). This outlet should be relocated, suggest consulting with a licensed electrician.

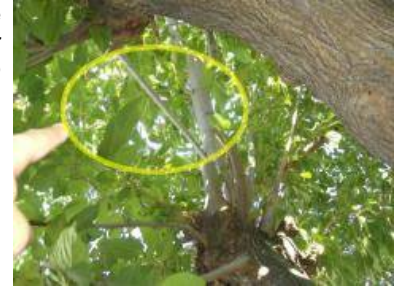
When the utility company wiring coming into the house are sagging, frayed, run through trees, or otherwise appear improper, we advise the Client to contact the utility company to correct the condition or verify its safety.

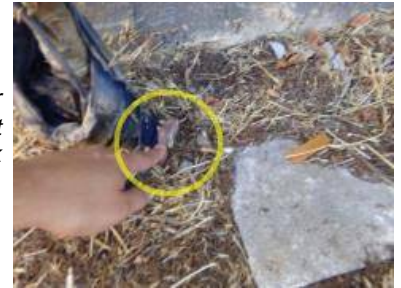
Main shutoff valve is located at front of home.  
- Shut off valve is buried.

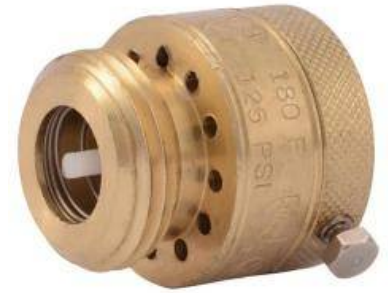
Suggest installing a vacuum breaker (backflow prevention device) to all exterior hose bibs since standing water in a hose line or other hose bib attachment may become contaminated and backflow into the potable water supply (thus contaminating it)

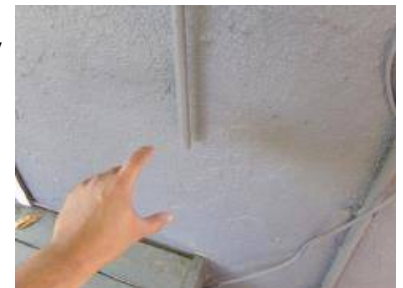
- Pressure relief valve drain line ends prematurely and should be extended.

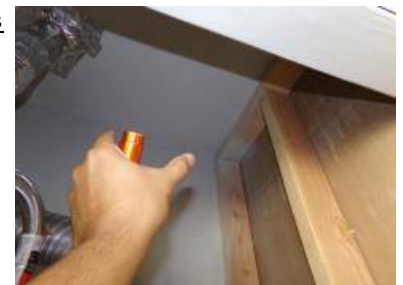
Combustion Air:

The combustion air supply is not adequate. Lacks proper venting, advise correction for safety.

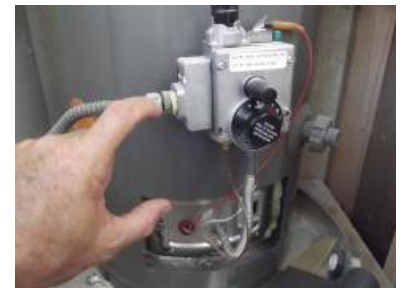
It was noted that the gas line supplying this water heater is not provided with a sediment trap or 'drip leg' as recommended by the appliance manufacturer.

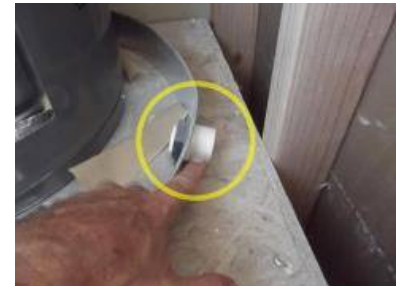
Drain pan does not have a drain line installed.

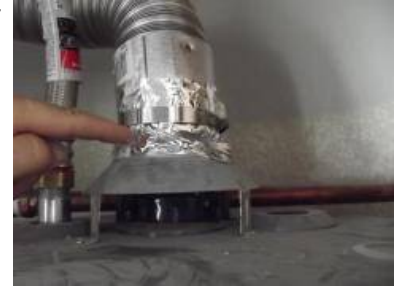
## 805b Venting #1:

Exhaust vent material lacks screws at draft diverter to tank or pipe connections to prevent separation during an earthquake . We recommend correcting the condition(s) noted.

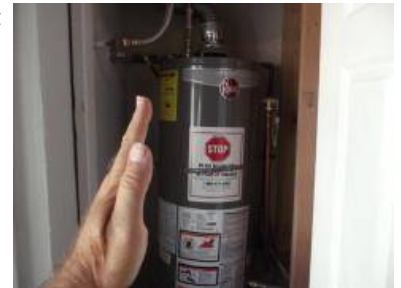
Water heater was not plumb. We recommend that the water heater be adjusted to be vertical.

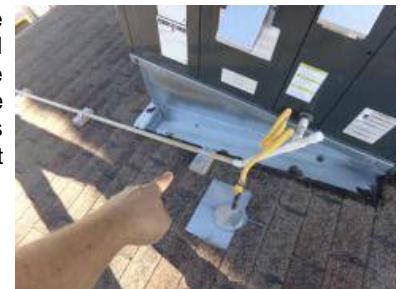
Condensate drain line(s):

Condensate line drains on the left side of the home into the gutters. We did note that the PVC material was not painted and the blocks installed to elevate the pipe were not treated or redwood material. The unpainted PVC can get damaged by the UV rays and the wood blocks will deteriorate over time if not painted.

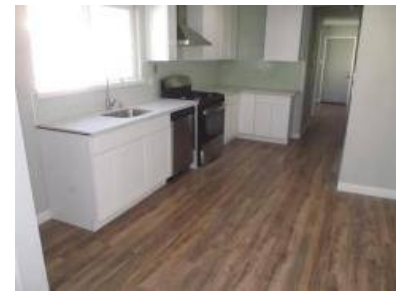
Located on left side of home.

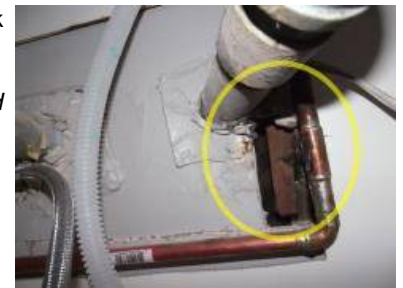
Gap(s)/holes noted around the under-sink plumbing. Recommend (re)sealing.

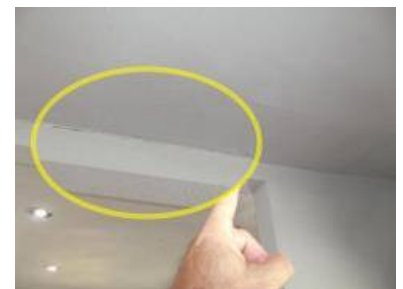
903 Ceiling:

Stress/shrinkage/settlement cracks noted.

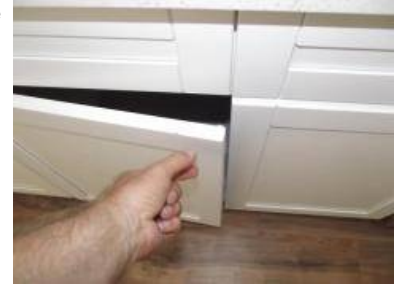
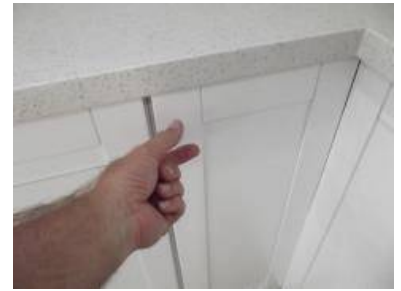
**907 Cabinets:**

New cabinets were installed but do not have handles installed.

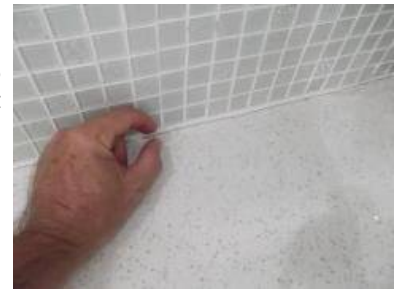
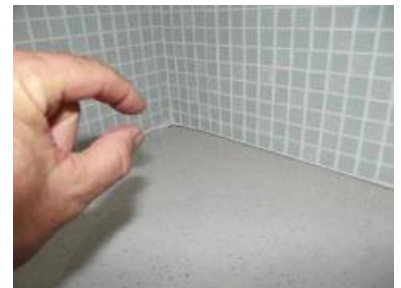
**908 Counter tops:**

Rock material.  
- Recommend (re)sealing the base of backsplash as needed, (especially at sink area), so as to prevent possible moisture intrusion and subsequent damage.

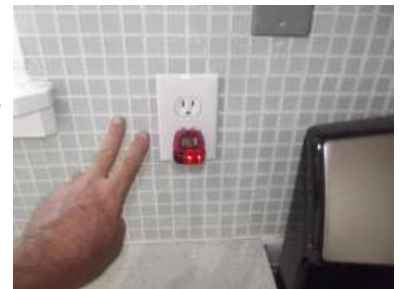
**909 Electric Fixtures:**

Grounded outlet(s) noted in kitchen. Building code now requires that all outlets in a kitchen be GFCI protected. Although not required in this case, upgrading all outlets to GFCI protection status is recommended, for safety reasons.

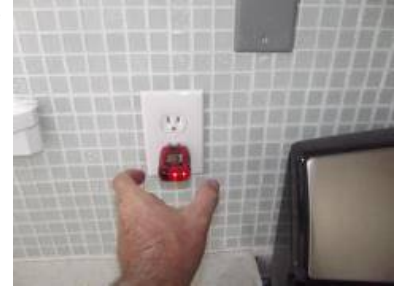
Some outlet(s) are loose. For maximum safety we recommend that loose outlets be re-secured.

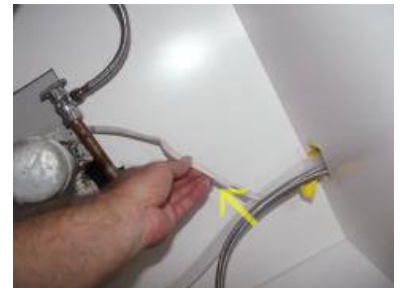
Electrical wiring installed for the dishwasher was installed behind the cabinets on top of the walls. This is not installed according to industry standards. This type of work observed suggests that the electrical work has been performed by a nonprofessional. We recommend further review and repairs be performed by a licensed electrician.

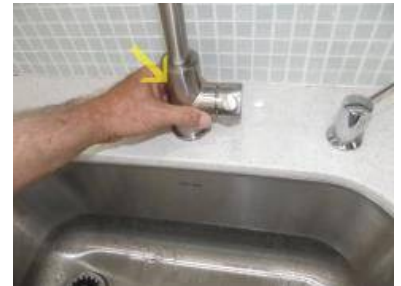
911 Faucet:

Loose faucet noted.

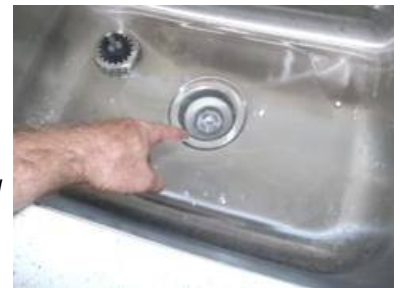
912 Traps/Drains/Supply lines:

Slow drain noted. We recommend that the trap be cleaned of grease, hair, sludge etc and if this does not correct the problem, we recommend the line be 'snaked' by a professional cleaning service.

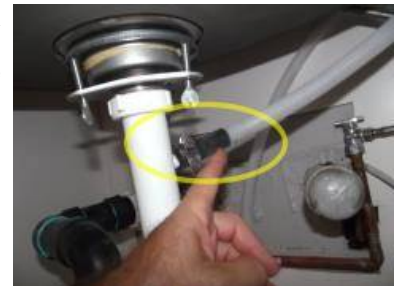
914 Dishwasher(s):

The dishwasher was connected directly to the sink drain piping. The dishwasher should connect to an air gap device and from there to the garbage disposal or sink drain piping. We recommend correcting the condition(s) noted.

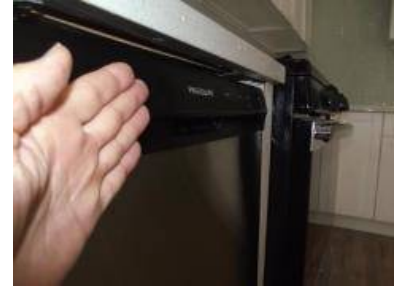
Dishwasher was not installed flush with cabinets and was too far recessed. We recommend correcting the condition noted.

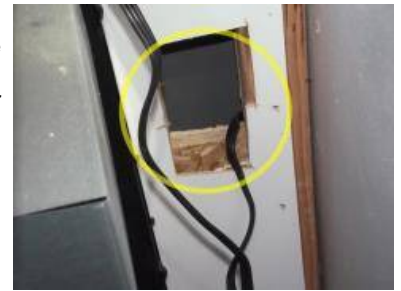
*915 Stove/Cooktop(s):*

The receptacle for the cooktop ignition system was not accessible/visible. The plug should be accessible for maintenance and emergencies. We recommend correcting the condition(s) noted for safety reasons.

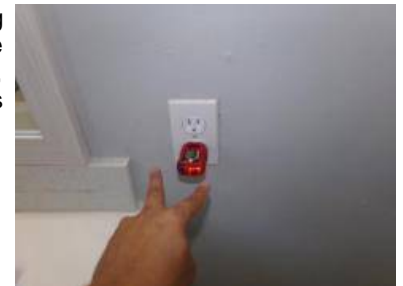
1007 Electrical:

Grounded outlet(s) noted in bathroom. Building code now requires that all outlets in a bathroom be GFCI protected. Although not required in this case, upgrading all outlets to GFCI protection status is recommended, for safety reasons.

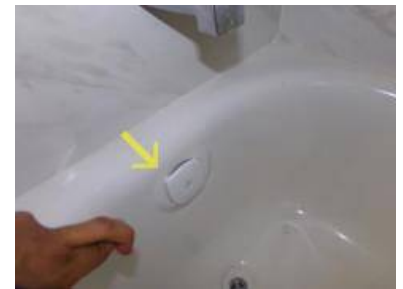
Over flow drain cover was reversed.

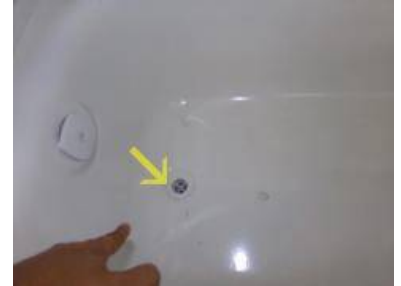
Tub lacks stopper.

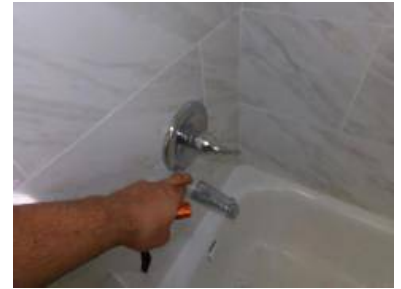
1012 Tub Faucet:

Hot and cold orientation reversed.

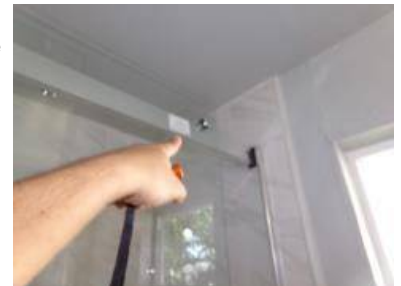
1014 Shower Door:

One of the doors has stiff operation and may not be properly installed. We recommend correcting the condition noted.

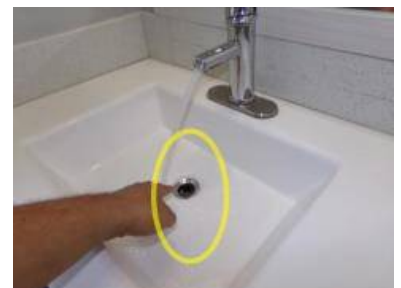
1016 Sink:

Lacks stopper.

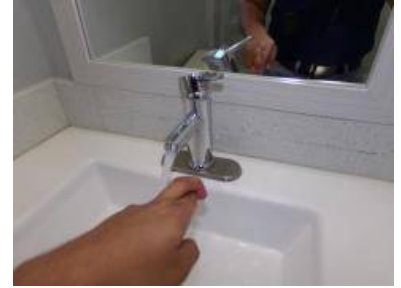
1017 Sink Faucet:

Hot and cold orientation reversed.

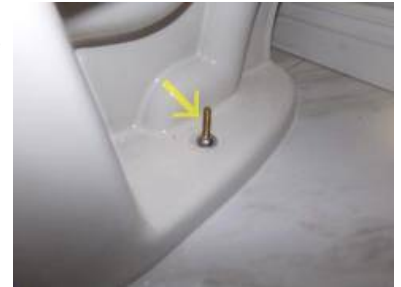
1019 Toilet:

Toilet flushed well and was stable but the base bolts are missing caps. We recommend correcting the condition noted.

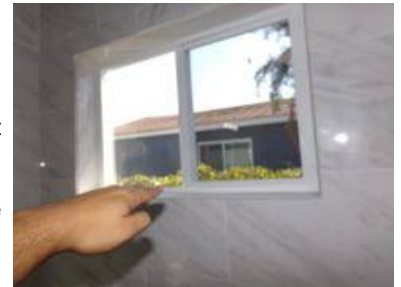
1030 Windows:

Window in the path of shower spray was noted at hallway bathroom. Whenever a window is positioned below a shower head, water infiltration is always a concern. Moisture can enter any seam, deficient grouting, or crack in framing material that forms part of the seams or joints around a window. While removing or downsizing window may be the best option, we recommend (periodic) review of the seals/joints around such windows.

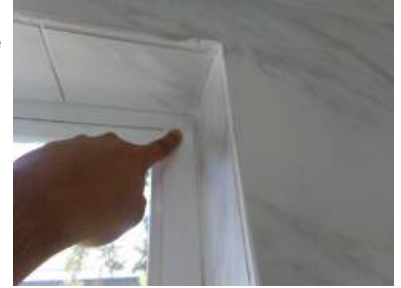
Window was inadequately installed. Daylight was visible around the window and leakage is likely. We recommend that the window be reviewed and properly repaired by a licensed contractor.  
\*Window appears to be single pane.

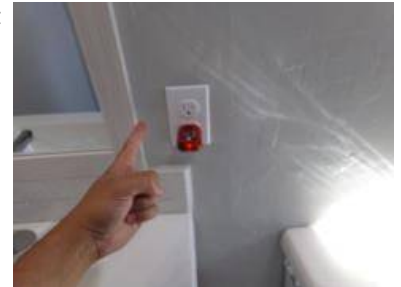
1032 Electrical:

Ungrounded 3-prong outlet. This configuration is not recommended. Correction recommended.

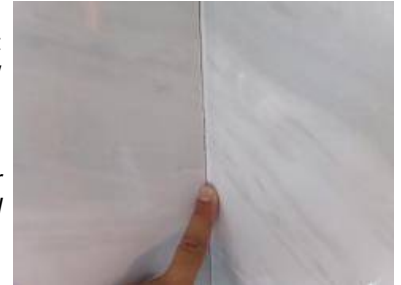
- Some of the grout was cracked, We suggest regrouting as needed, open joints may allow moisture intrusion. Maintenance of the joints is strongly advised.

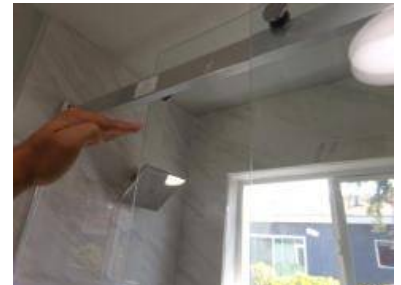
1039 Shower Door:

One of the doors rolls due to the track not being horizontal. We recommend correcting the condition noted.

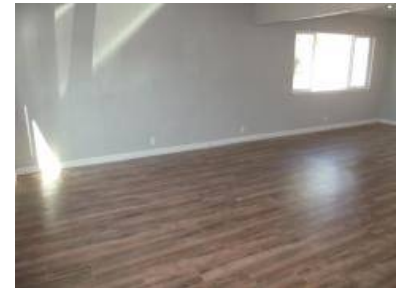
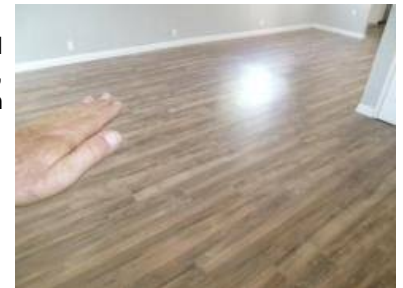
- The floor is sloped. Individual perception and sensitivity to floor sloping varies greatly. However, the slope in this case is significant. See foundation section of this report regarding this issue.

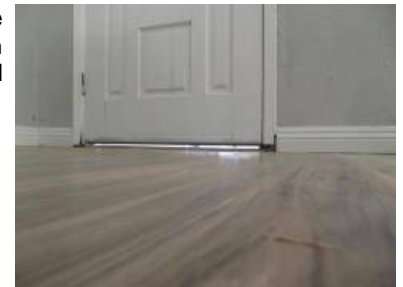
1204 Doors:

Door is split at joints and also has daylight visible under the door. Gap(s) noted at front door when closed. Suggest (re)installing weather strip material at door jamb for energy efficiency reasons.

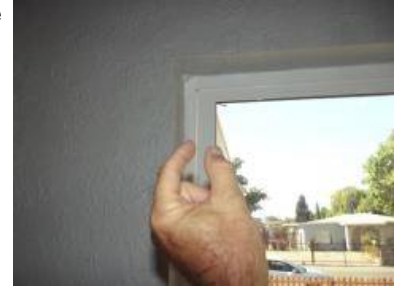
*1205 Windows/Screens:*

Front window does not close. Window may not be vertical, suggest correcting the condition noted.

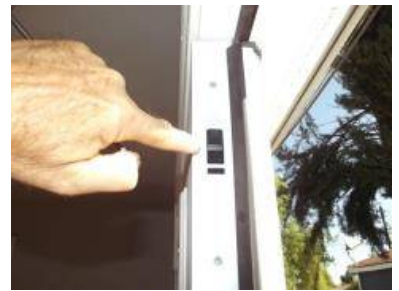
1604 Doors:

One side of the french door does not open and needs repair/adjustment.

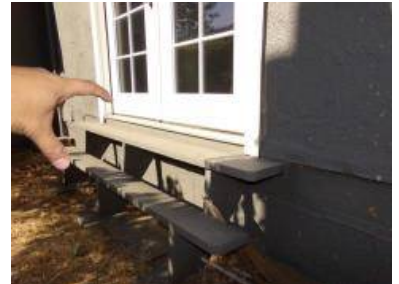
A.) The exterior landing was too small. The landing should be a minimum of at least three feet square. We recommend correcting the condition(s) noted for safety reasons.

B.) There was improper rise/run on steps/stairs. This condition is a trip hazard. We recommend correcting the condition(s) noted for safety reasons.

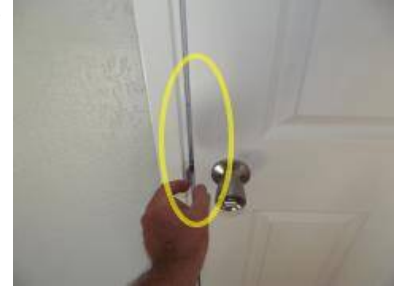
Daylight was visible around the door(s).  
recommend correcting the condition(s) noted.

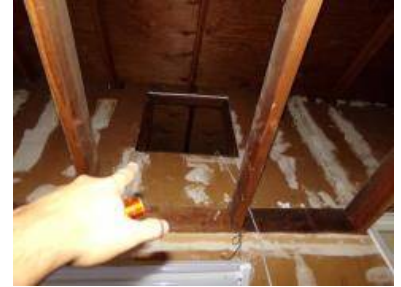
- No access hatch cover was installed. This violates the integrity of the fire wall, correction is advised.

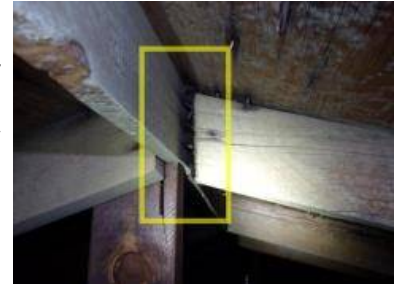
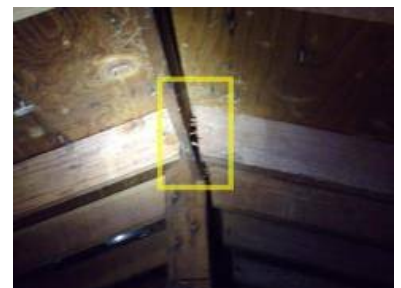
- Framing members are separated at ridge in numerous locations. It is recommended that further evaluation be made by a licensed general contractor/framing carpenter or if necessary, a structural engineer.

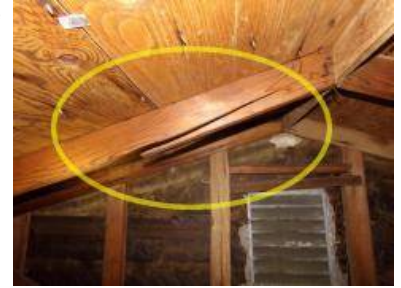
Broken rafter was noted at the rear left side of the attic. We recommend that client contact a licensed contractor for further evaluation and determination of the necessary corrective measures.

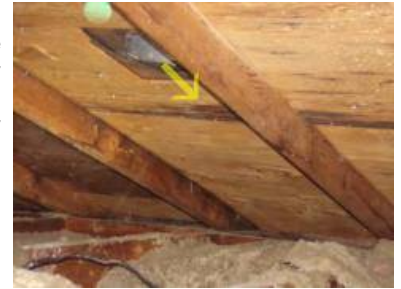
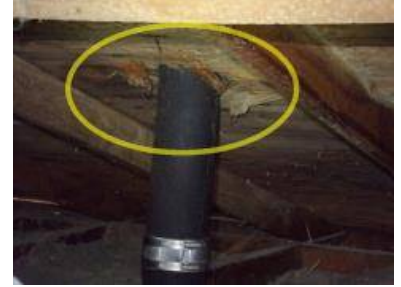
1754 Evidence of leaking:

Yes, evidence of leaking noted, unable to determine cause or if active, We recommend locating the source and correction and replacement of any damaged materials, suggest complete review/correction including cost estimate (bids) by appropriate person before the close of escrow.

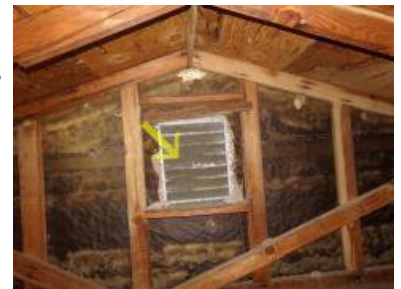
1756 Ventilation:

Vents are located at soffits and gables. However, the screens were either dirty and/or painted which restricts air-flow. We recommend that all the vents be cleaned to improve the flow of air in the attic.

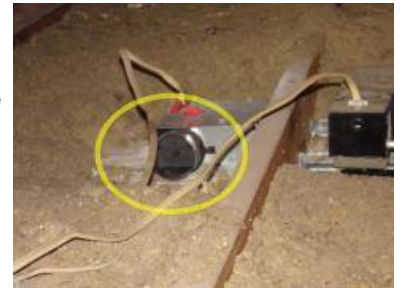
1757 Exhaust Vents:

Kitchen hood and master fan do not have vent pipes installed and blow air into the attic. This condition can allow moisture to buildup in the attic. Suggest complete review/correction by appropriate person.

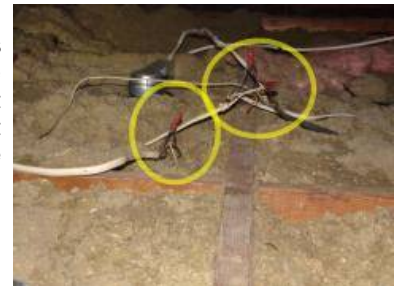
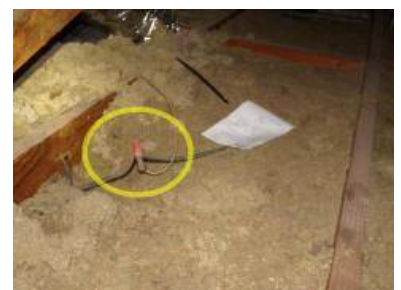
1759 Comments:

Open splices/open junction boxes were noted. This is a safety concern. Whenever an electric wire is cut and reconnected, the "splice" should be encased in a covered junction box to prevent shocks and separation of the splice. We suggest review/correction by a licensed electrician to ensure safety.
