Sacramento Home Inspections +

Confidential Inspection Report

1234 Nowhere Dr,
Sacramento, CA 95820

September 2, 2019

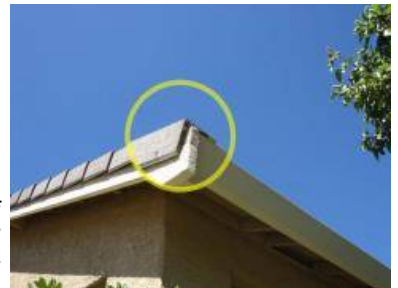
[NOTE] - *Typical weathered conditions noted on exterior wood members. Wood is an organic material so some degree of splitting/cracking/chipped material etc. is typical and to be expected. Recommend evaluation of exterior wood members' condition/integrity by a licensed, Branch III, structural pest control operator in order to determine whether any remediation or (re)sealing is deemed necessary at this time.*

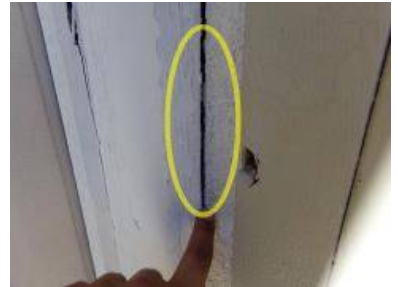
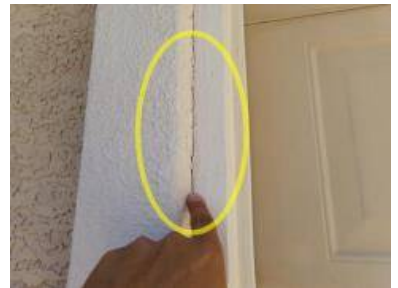
Trim (siding, doors and windows) have gaps/voids that need to be sealed. As a preventative maintenance measure we recommend caulking/sealing all voids at siding joints, common trim, and around windows and doors to avoid the possibility of water intrusion and damage. All materials should be kept painted to avoid the possibility of moisture related deterioration.

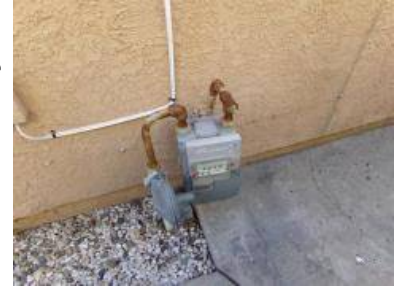
Rust noted on gas pipe, suggest repainting rusted surfaces.

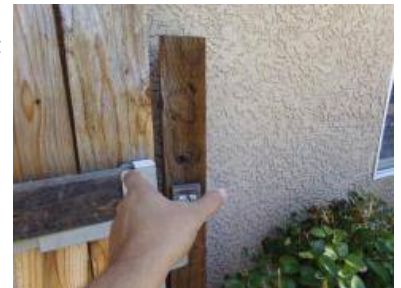
204 Gates:

Secondary gate on the right side of the home does not properly latch due to a weak post. The post yields to applied pressure and should be stabilized .

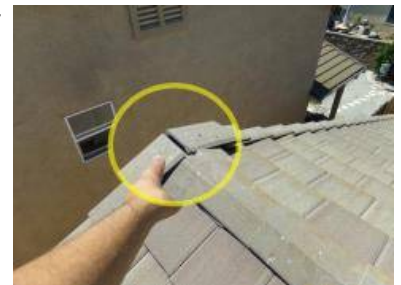
Ridge, rake and/or hip tiles junctions are lacking or have deteriorated seals. We recommend that all junctions be resealed to prevent moisture intrusion.

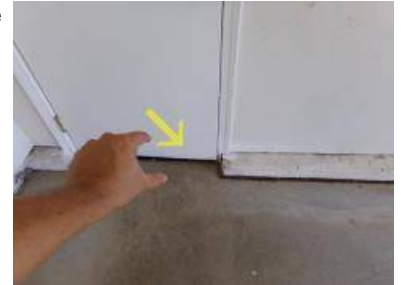
606 Access Door:

Door binds. The door rubbed the threshold, We recommend correcting the condition(s) noted.

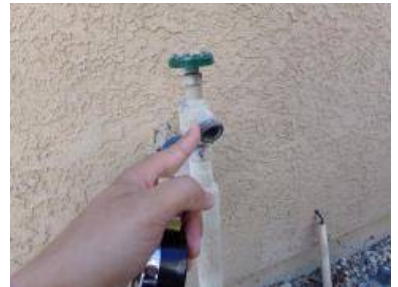
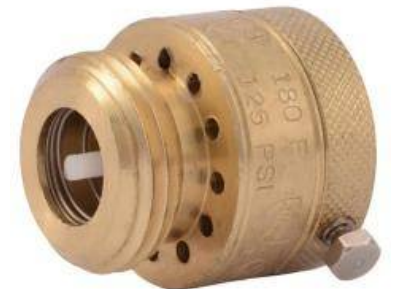
Suggest installing a vacuum breaker (backflow prevention device) to all exterior hose bibs since standing water in a hose line or other hose bib attachment may become contaminated and backflow into the potable water supply (thus contaminating it)

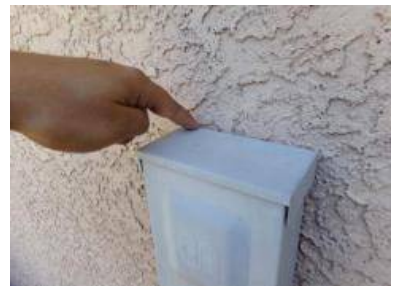
Electrical disconnect as required at unit.
 - The electrical disconnect box is not sealed/caulked at the wall, moisture intrusion possible, sealing/caulking suggested. We recommend correcting the condition(s) noted.

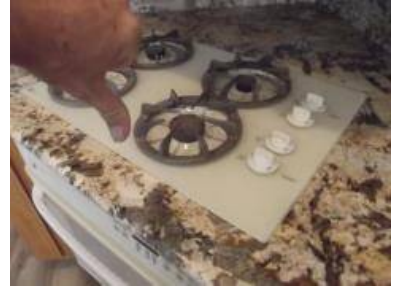
915 Stove/Cooktop(s):

A.) Unit was inoperable; The receptacle for the cooktop ignition system was not accessible/visible. The plug should be accessible for maintenance and emergencies. We recommend correcting the condition(s) noted for safety reasons.

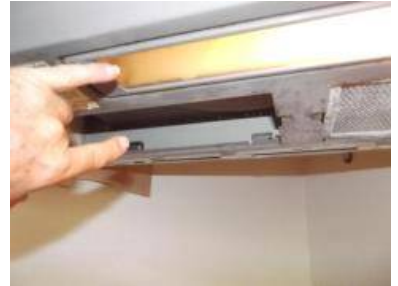
917 Hood/Fan Light:

Unit was functional
- Filter was missing.

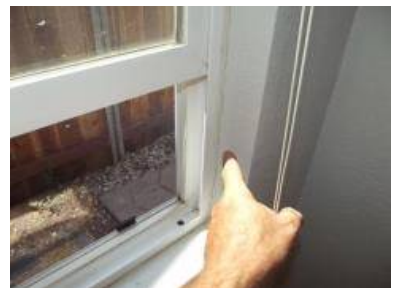
935 Windows:

Side window frame caulking has cracked. We recommend that the old bead be removed and a new seamless bead be applied.

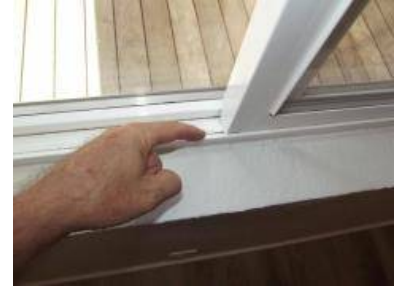
Rear sliding window was difficult to operate and would benefit from cleaning and maintenance.

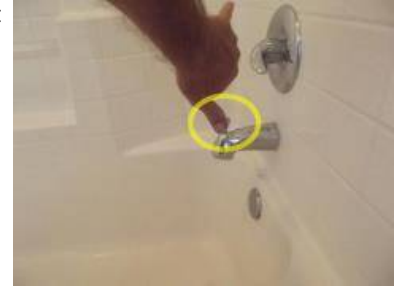
1015 Shower Faucet:

Shower diverter handle on the tub spout does not fully divert water to the shower.

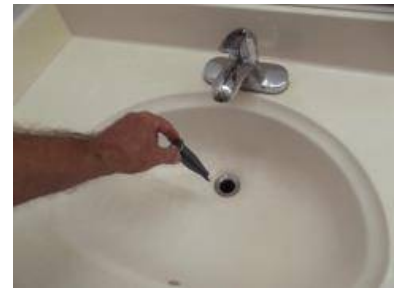
1016 Sink:

Stopper was disconnected.

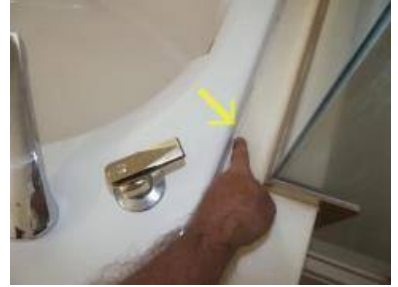
- 1028 Ceiling: S
- 1029 Doors: S
- 1030 Windows: S
- 1031 Screens: S
- 1032 Electrical: S, Ground fault circuit protected for safety.
- 1033 Exhaust Fan: S
- 1034 Heating: S, Register.
- 1035 Tub & Surround: Some voids noted at caulked joints. We suggest caulking as needed, open joints may allow moisture intrusion. Maintenance of the joints is strongly advised.

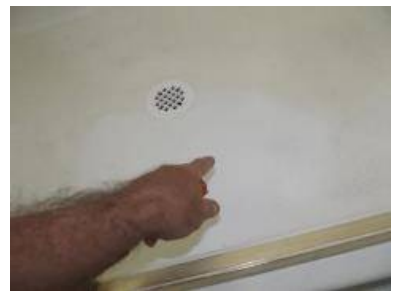
- 1038 Shower & Surround: Shower pan was repaired. Appears to be serviceable.

Shower pan weep holes were sealed. These weep holes should not be caulked or grouted over. If water ever gets trapped behind the tiles the weep holes allow water to drain out. We recommend correcting the condition noted.

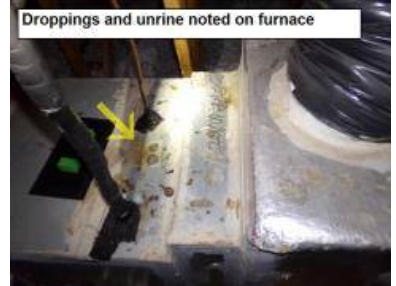
1759 Comments:

Evidence of past rodent activity noted in attic. Rodents are a potential source of damage and disease. Recommend further review/correction by qualified contractor (Branch II pest inspector) at this time.
